Campus Exterior Architectural Plan 2.0

Scranton

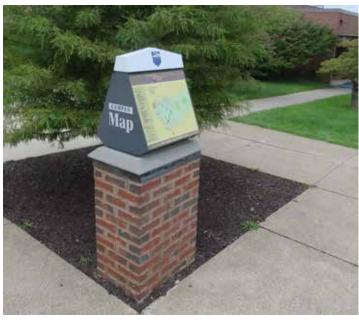
Replace way-finding sign panels because of deterioration

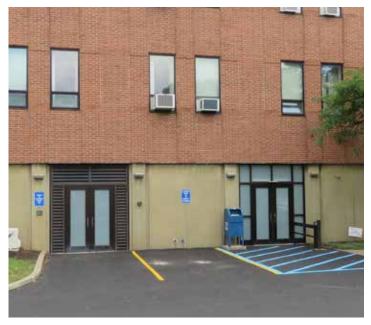
Avoid signs on buildings and temporary "yard" signs

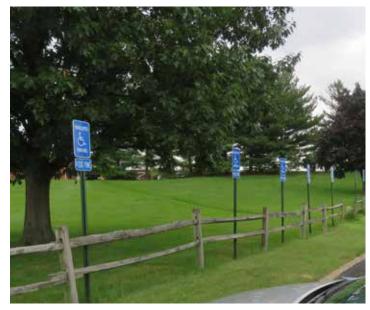
Update to standard sign and sign post

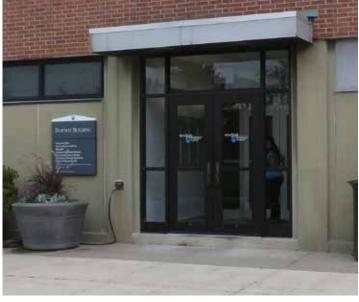
Update Penn State logo throughout campus

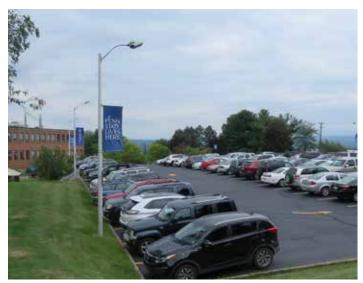
Non-standard parking lot light fixtures at Dawson parking lot

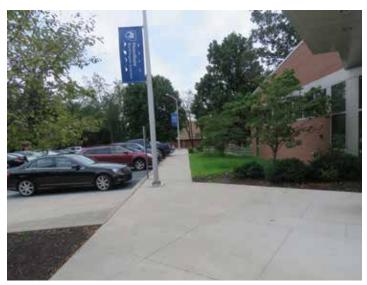
Non-standard parking lot light fixtures at Business parking lot

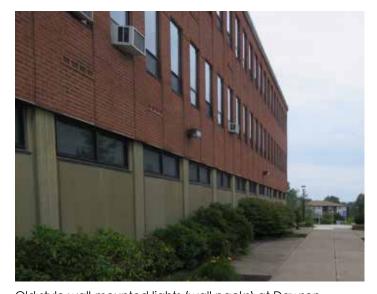
Old style wall-mounted lights (wall packs) at Dawson

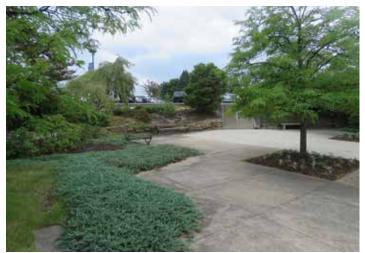
Unprogrammed paved areas & not needed for circulation

The previous recommendations were helpful but mostly cosmetic. A more substantial renovation is needed with a scope that potentially includes: replacement and substantial reduction of pavement, removing and replacing retaining walls with vegetated slopes, and improving pedestrian connections to parking lot with possible accessible route.

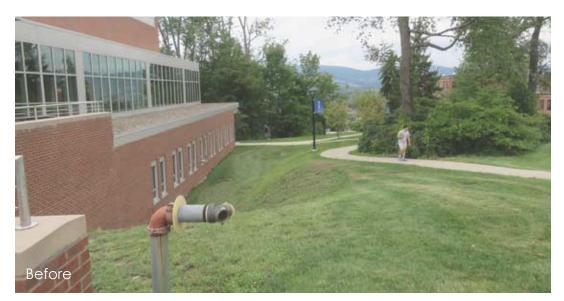
Landscaping is missing and standpipe is unsightly - recommend adding vegetation around building.

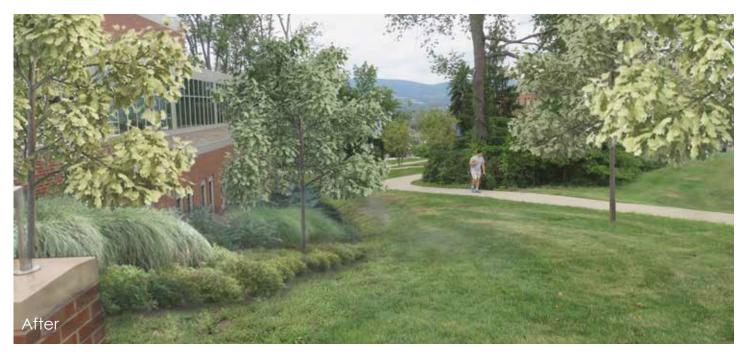
Steep slope is maintenance problem and eyesore - soften with vegetation

Enhance existing plantings to replace missing plants

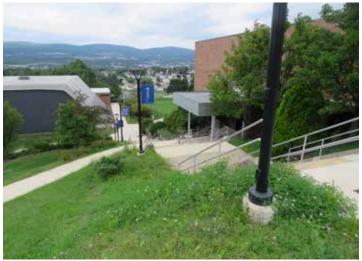
These steps are very steep and are unsightly from numerous repairs, as well as pose a serious maintenance and safety issue in winter. Timber retaining walls are residential in character and plantings are unruly and weedy. Replacement of steps seems imminent, which may provide an opportunity to consider options for a new alignment that is safer and easier to maintain. Consider these safer and lower maintenance design options looking forward.

Looking north toward mid-level entrance to building

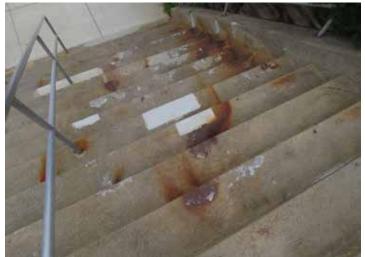
Close up view of patchwork repairs and ongoing decay

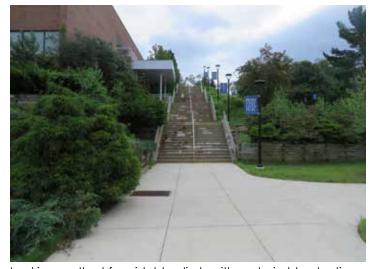
Looking south at formidable climb with undesirable plantings Close up of mid-level entrance from below

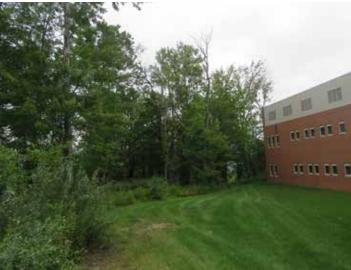
A sickly woodlot can be transformed to be an amenity

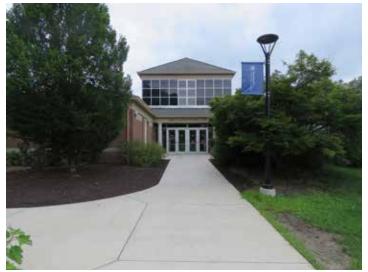
Missing plants on left side & overgrown plants on right side

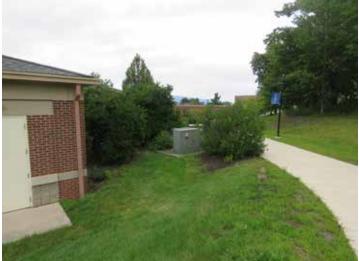
Gaps in screen plantings in a couple locations reveal utilities

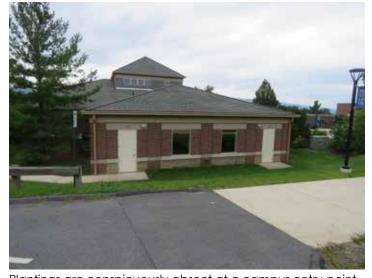
Plantings are conspicuously absent at a campus entry-point
