# Penn State Beaver

Campus Exterior Architectural Plan  
Spring 2010

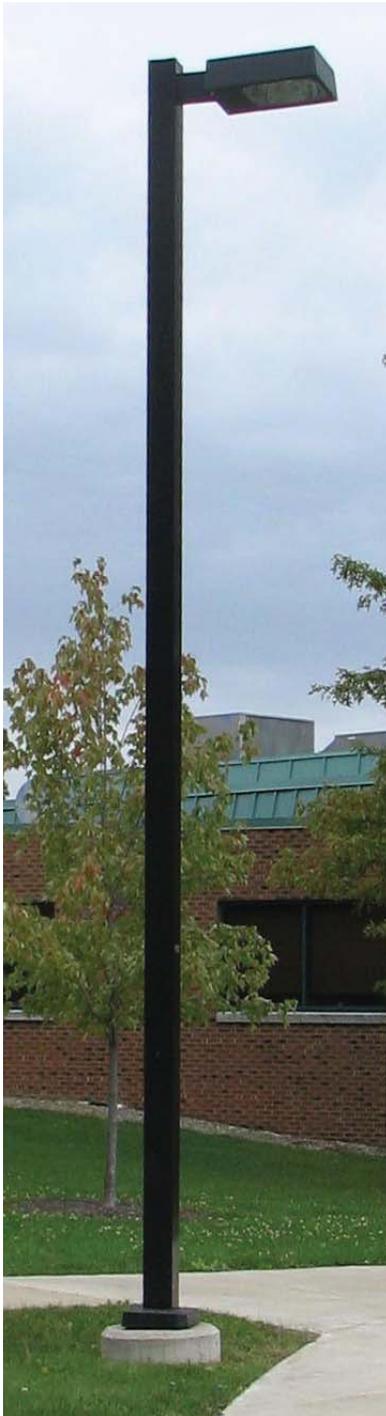
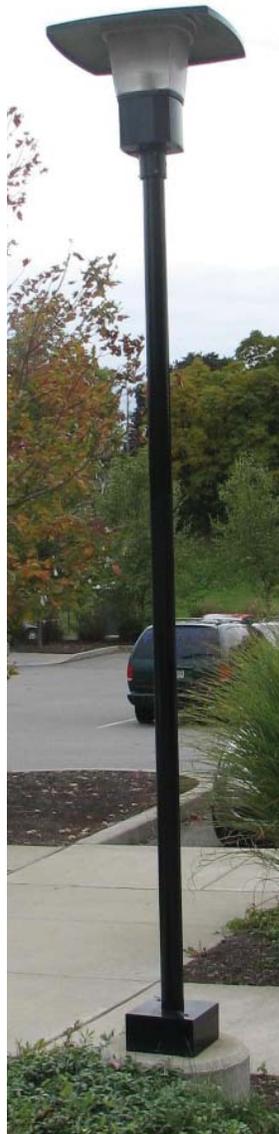
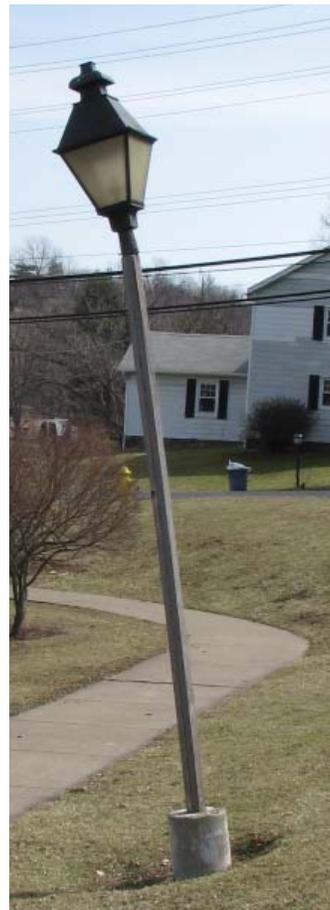
Exterior light fixture types are relatively uniform on campus. Fixtures and poles appear to be in good condition and are appropriately scaled. Inappropriate wall-mounted fixtures on buildings should be replaced.

The fixtures at the Brodhead Cultural Center are in need of replacement.

Replacement of any antiquated, inefficient pedestrian walkway and parking lot lighting is recommended.

Metal halide or LED lamps in cut-off luminaires mounted to poles are recommended for pedestrian walkways. High pressure sodium lamping is acceptable for parking lot lights. Color/finish for all fixtures should be consistent campus wide. Avoid the use of bollards due to vulnerability to snow removal operations and vandalism.

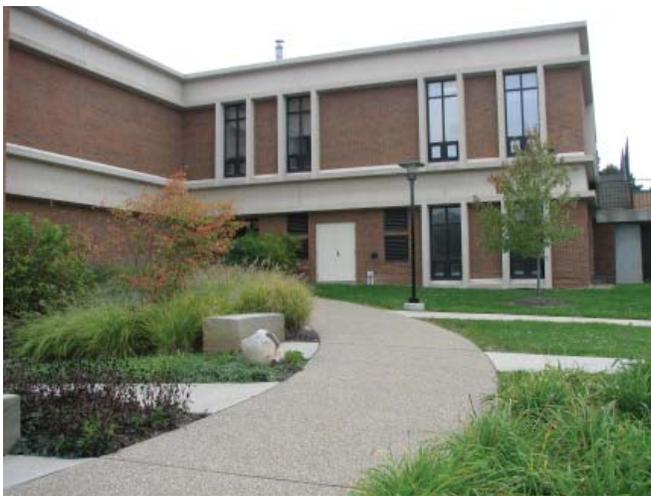
The color of the exterior doors on the Study-Learning Center should match the trim elements on the rest of the building.

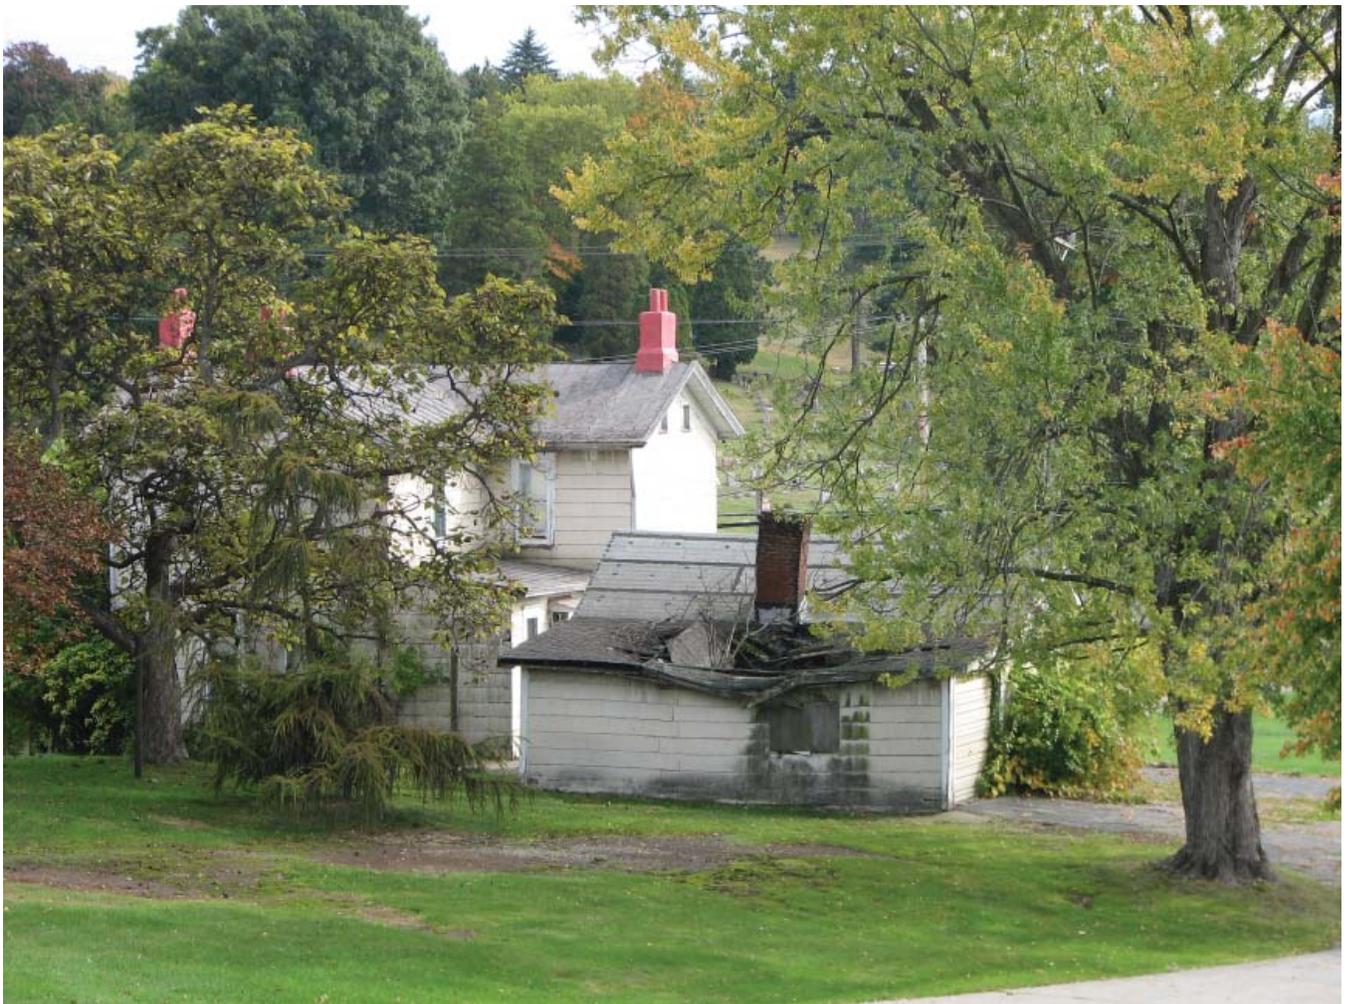
The ramshackle Hartenbach residence has become an attractive nuisance that should be demolished and cleared.

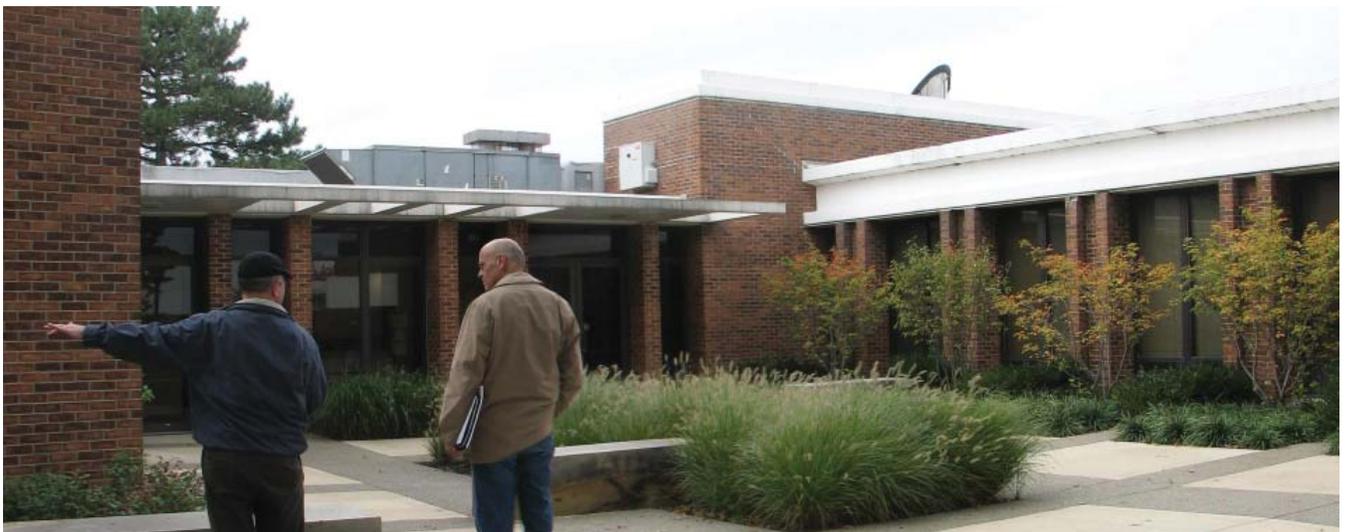
# 1c

The rooftop mechanical equipment on the General Classroom Building are plainly visible to passers-by. Recommend that the equipment be screened from view.

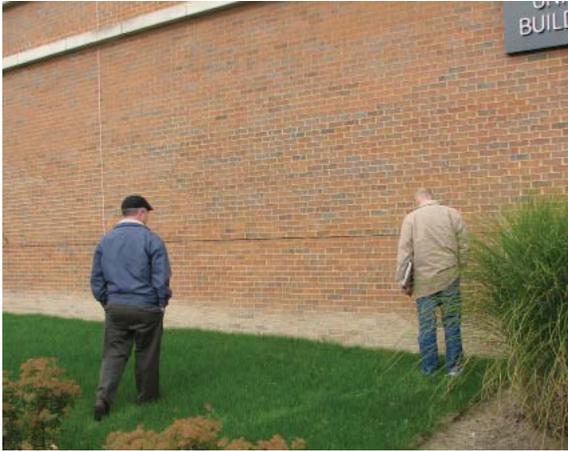
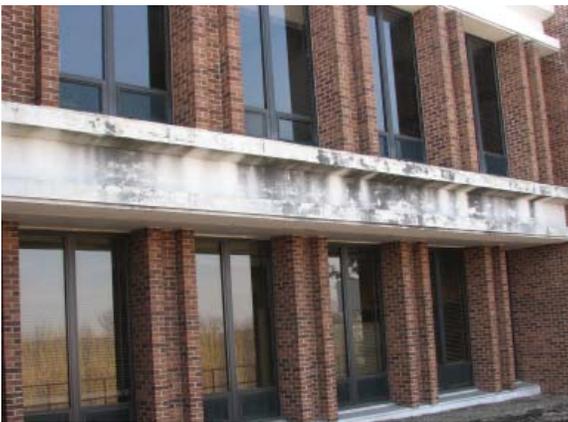
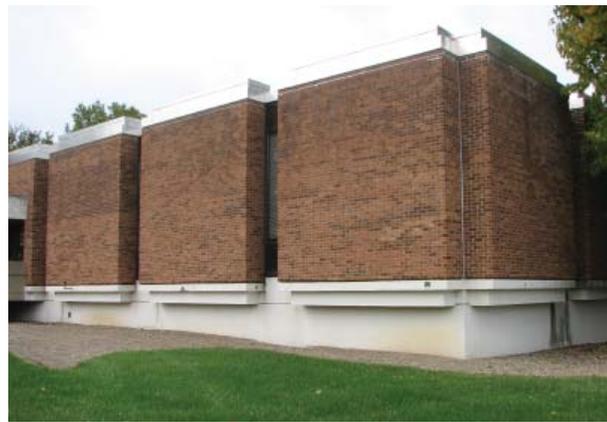
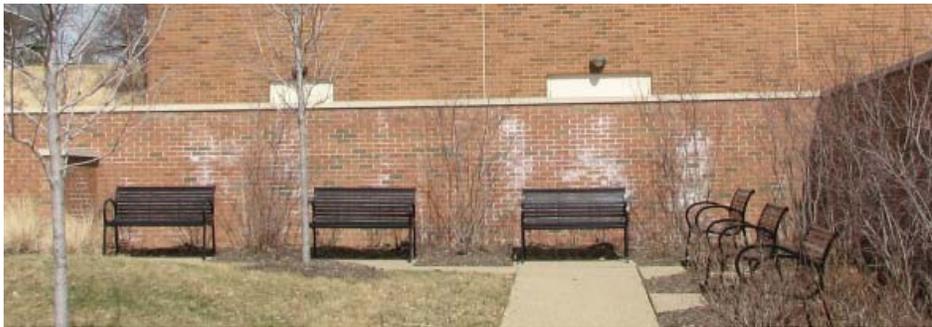
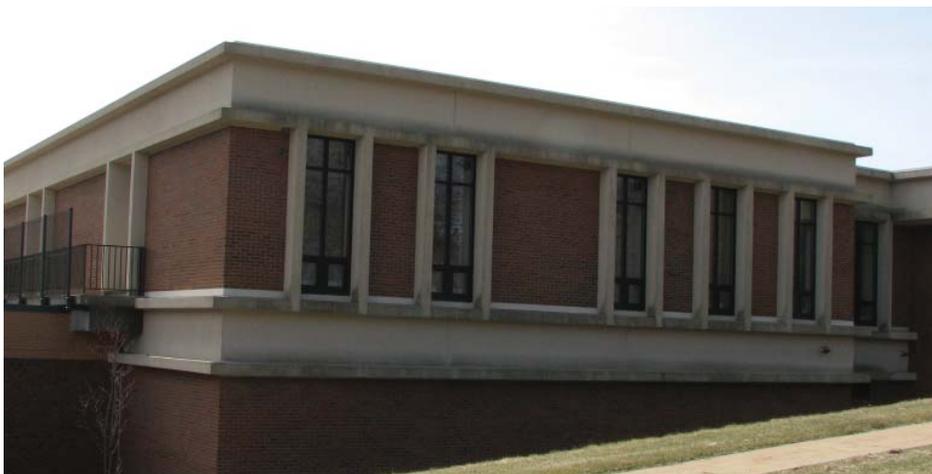
A cost effective strategy for freshening the appearance of existing buildings is the use of pressure washing to remove dirt and mildew stains. Propose the implementation of an annual cleaning program campus wide. Hand-cleaning may be necessary on certain finishes to avoid damage.

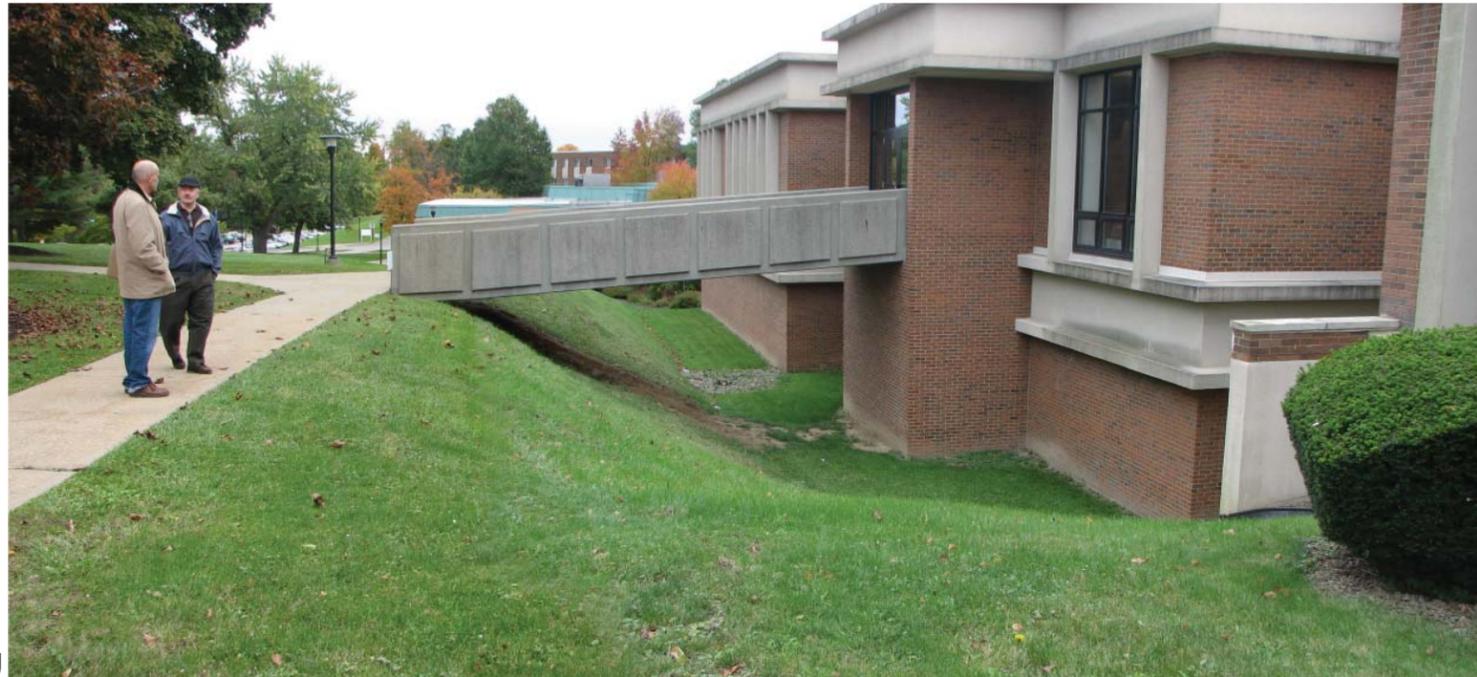
The north entrance to the Student Union Building, with its concrete bridge and precipitous slope, is uninviting and hazardous to maintain. A glass panel railing that echoes the window trim treatment would open up this side of the building. Low shade tolerant plantings are proposed. The design should accentuate the vantage point provided by the bridge.

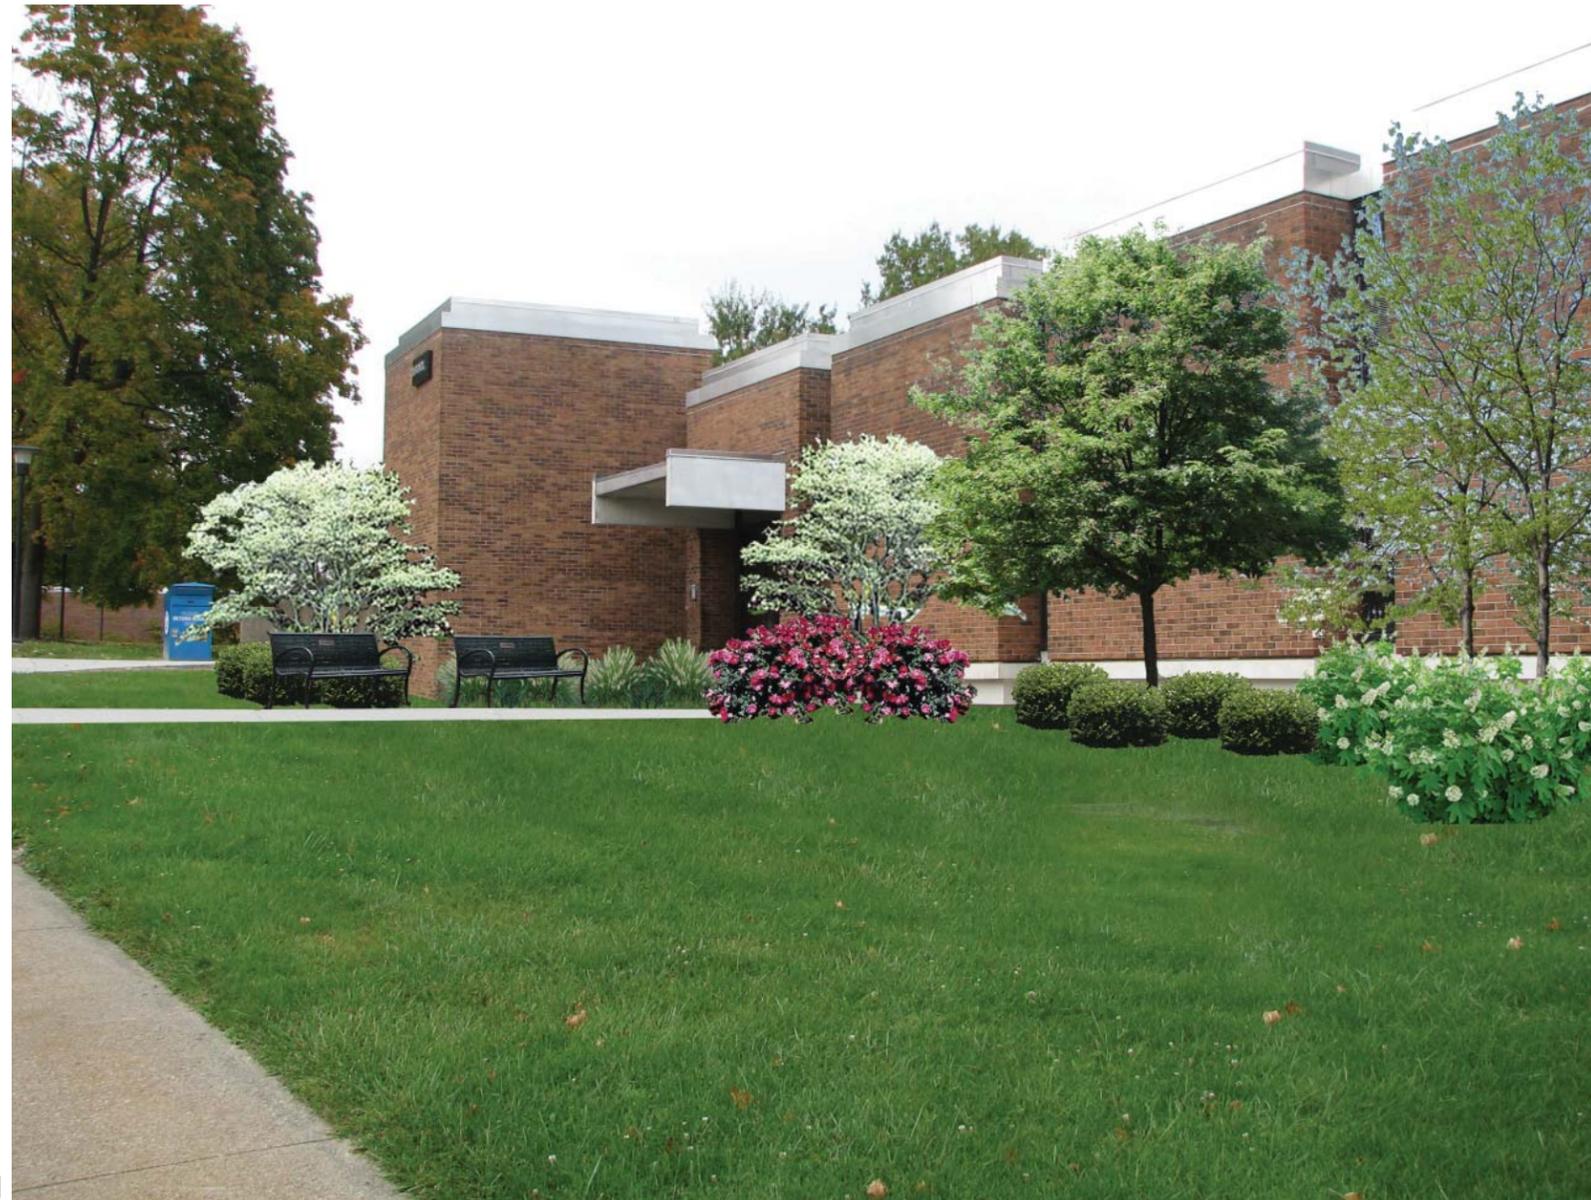
An alternative to a library entrance plaza, as conceptualized in the LaQuantra Bonci study, would be to backfill the grade, remove the bridge, provide a generous entry walk and landscape.

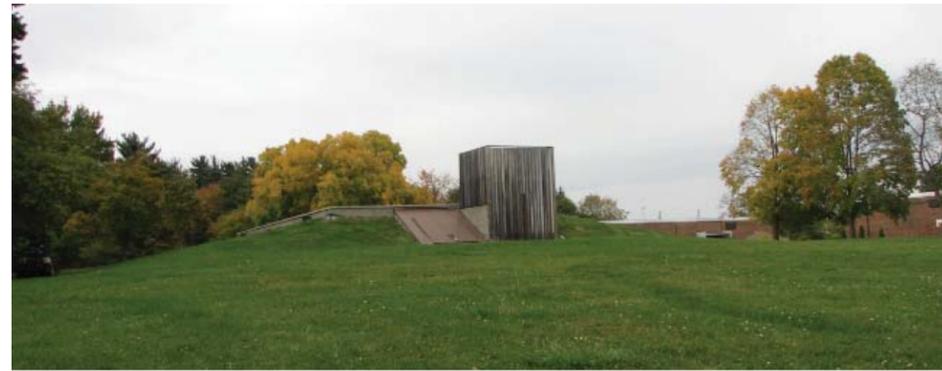
Electrical lines for generator service during power outages can be re-routed to the parking area next to the Baker Engineering Building. This would allow for the removal of the wooden shed next to the communications facility. Low brick walls constructed as illustrated will contain the condensing unit and camouflage the access doors. Regrade the surrounding earth to minimize the visual impact of the roof of the facility in the center of the campus green.

Elevation at top of brick wall surrounds same as top of Communications Facility

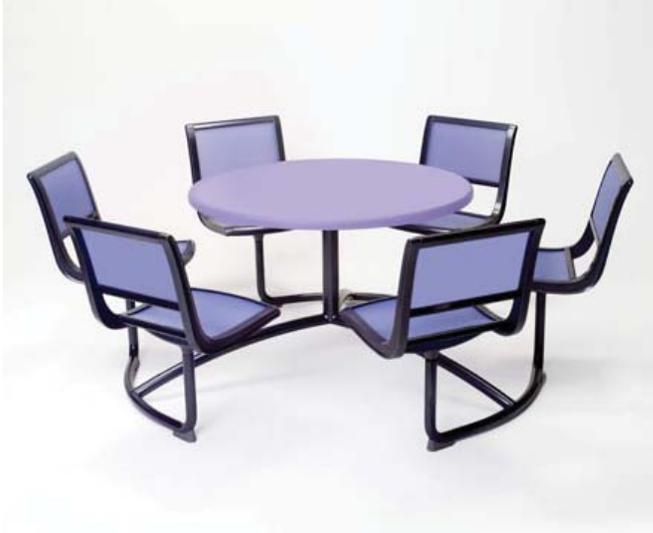
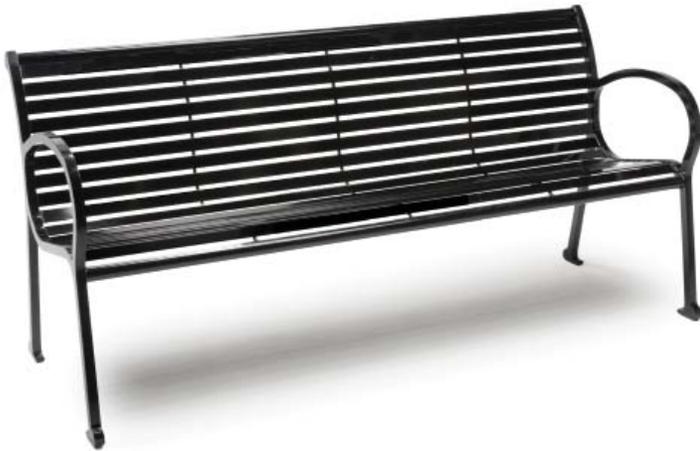
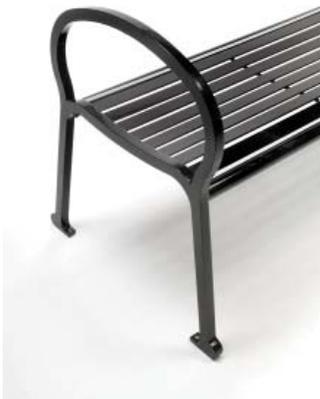
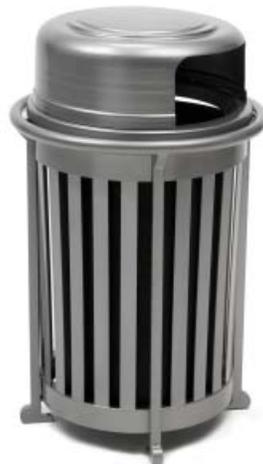
# 2A

Site furnishings designed in a style “family” are aesthetically unifying. The examples shown here will compliment the contemporary architectural style present on the campus. Powder coated metal is attractive, comfortable and durable.

Planters should be appropriately sized for the space they occupy and be constructed of durable, quality material.

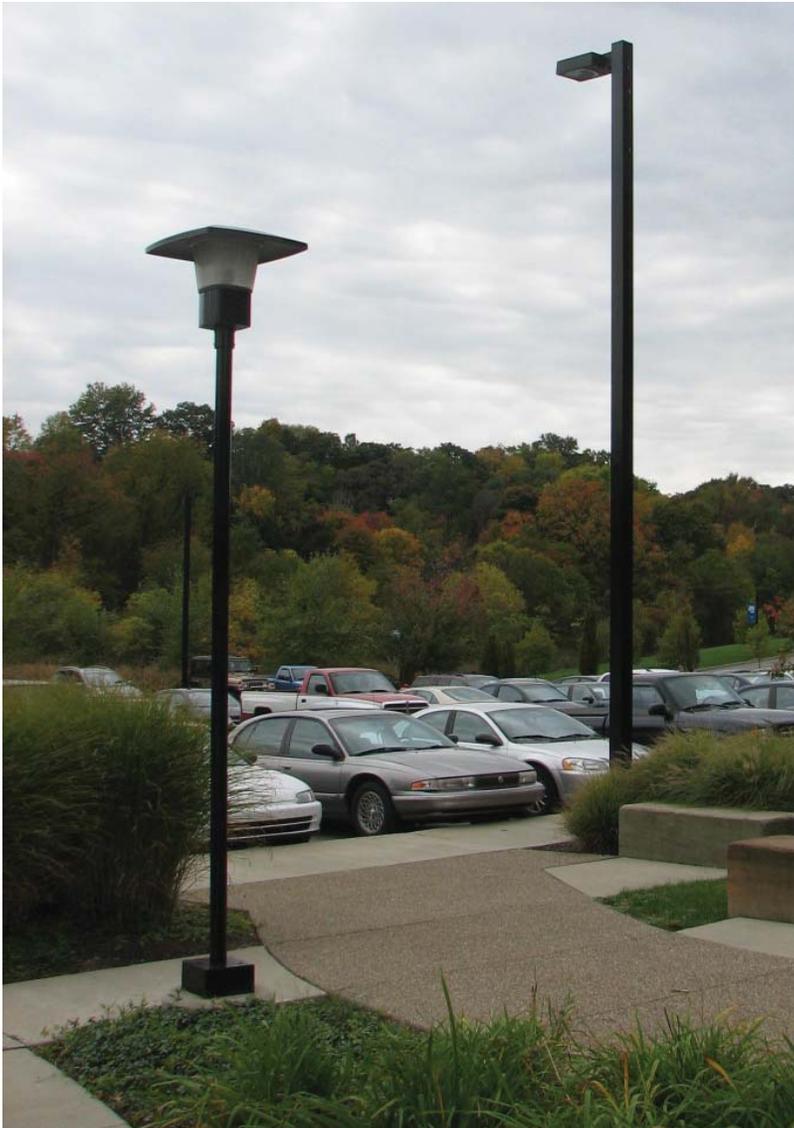
# 3A Lighting

Site Light

Parking Lot Light

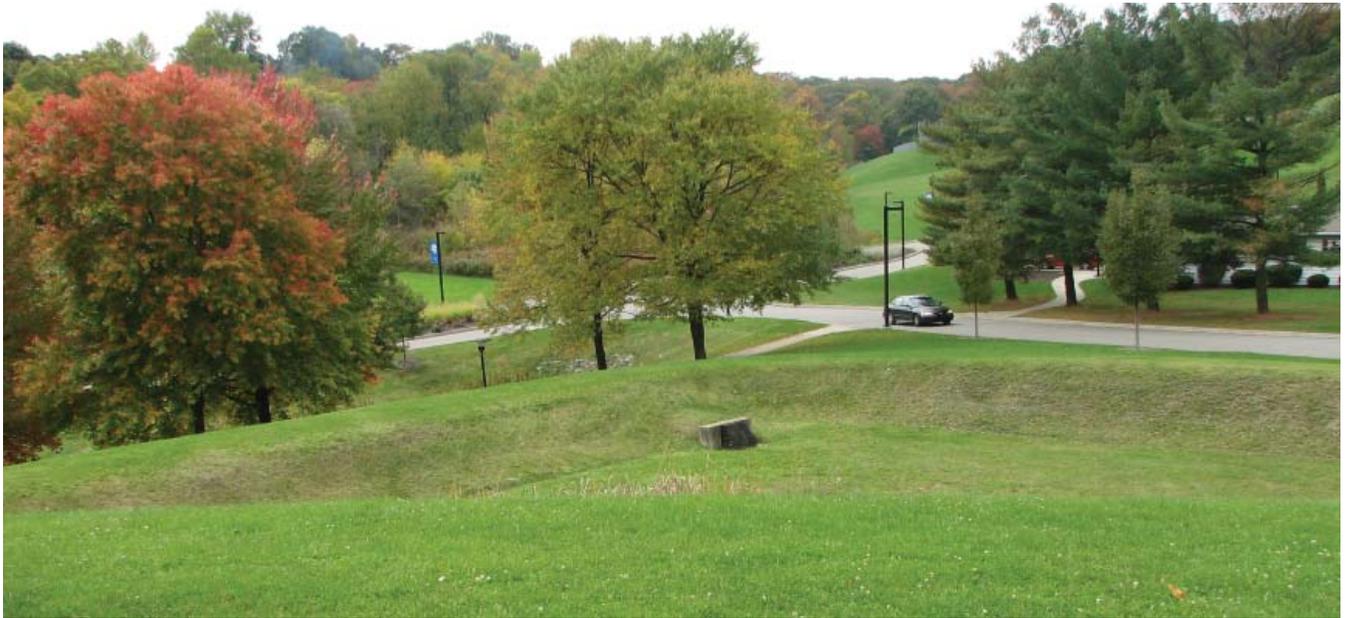
Retrofitting the stormwater basin with native plantings will beautify this utilitarian landscape element, reduce the grass-cutting burden, and promote Penn State's commitment to environmentally sustainable landscape practices.

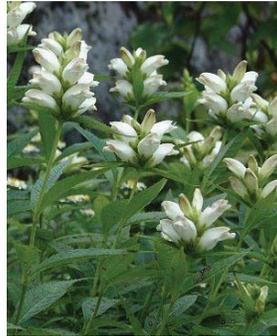
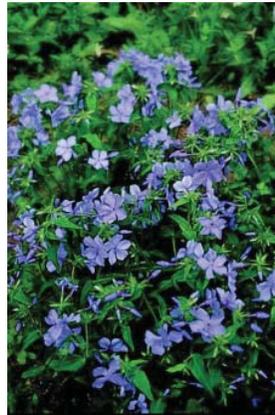
## Plant Along Waterway

An opportunity exists to stabilize the slopes of the waterway/swale between the entrance drive and the Brodhead Cultural Center. Native plants with ornamental qualities would beautify this highly visible area.

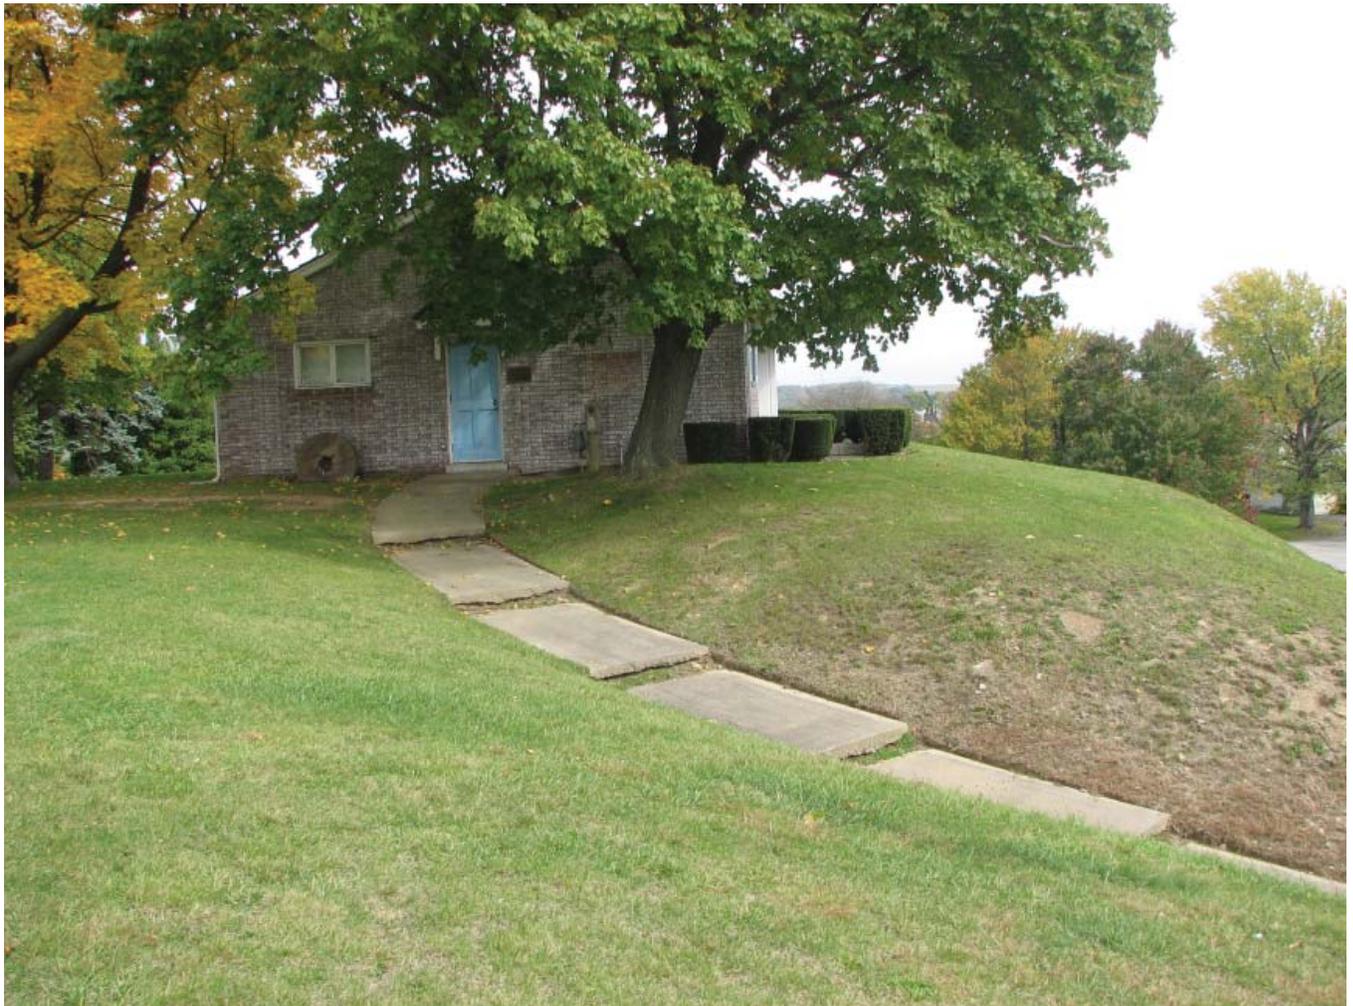
If the Museum is to remain in operation, the stairs to the Brodhead Cultural Center need to be rebuilt. The current configuration does not meet ADA requirements or provide a safe route from the Giusti Amphitheater.

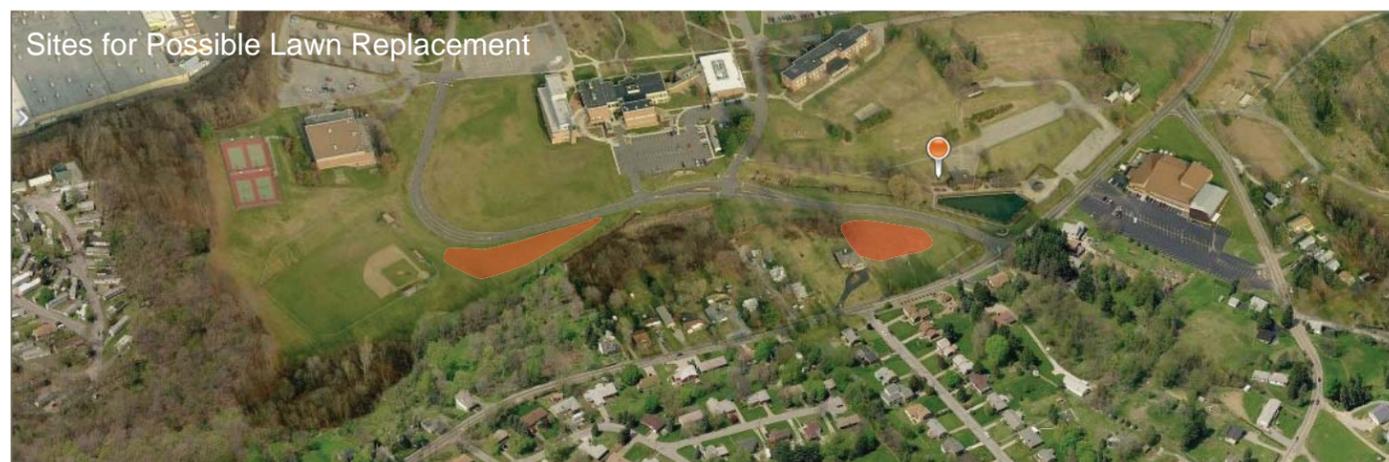
Warm-season meadow grasses in the highlighted areas along the entrance drive would complement the naturalistic entrance drive island plantings. These relatively small scale plots could serve as pilot test areas for an expanded meadow establishment program at Penn State Beaver.

Sites for Possible Lawn Replacement

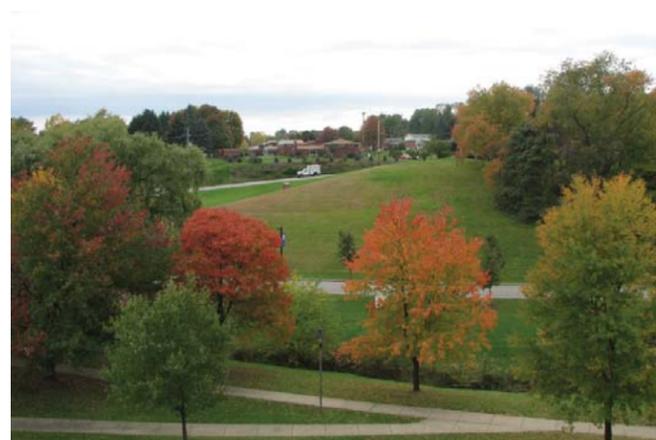
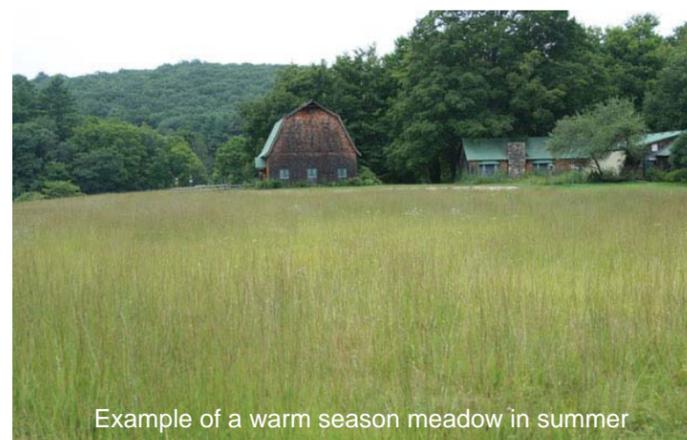
Example of a warm season meadow in summer

Beaver campus has a large turf-mowing burden. Areas of campus that are not regularly used by students can be converted to warm-season meadows to decrease the mowing burden and increase wildlife habitat. Once established, warm season meadows require minimal mowing and deep roots encourage stormwater infiltration.

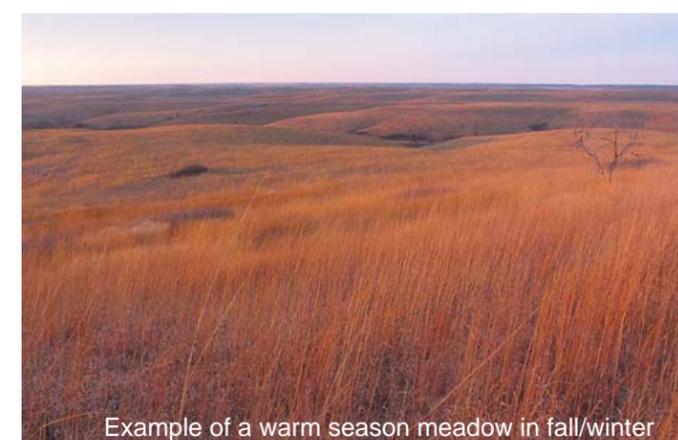
Example of a warm season meadow in fall/winter

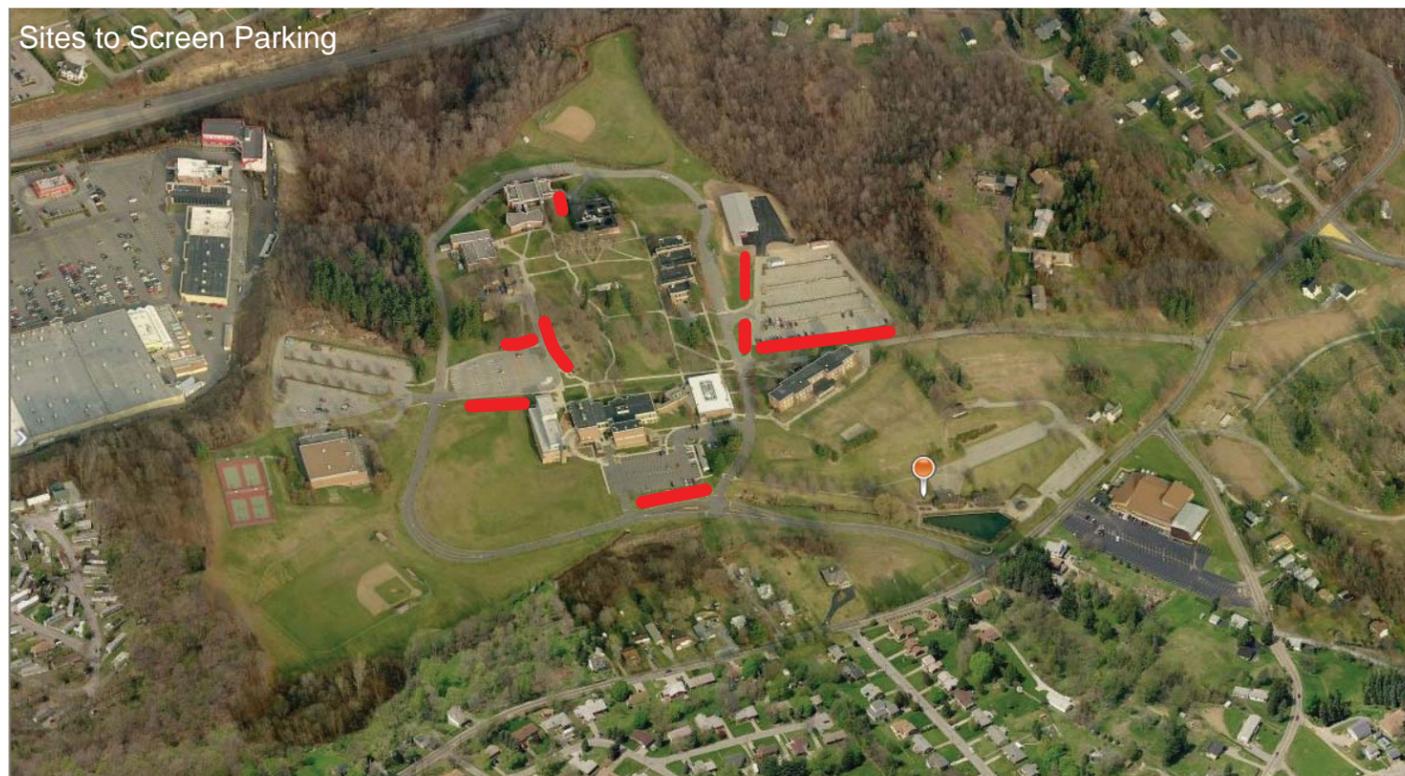
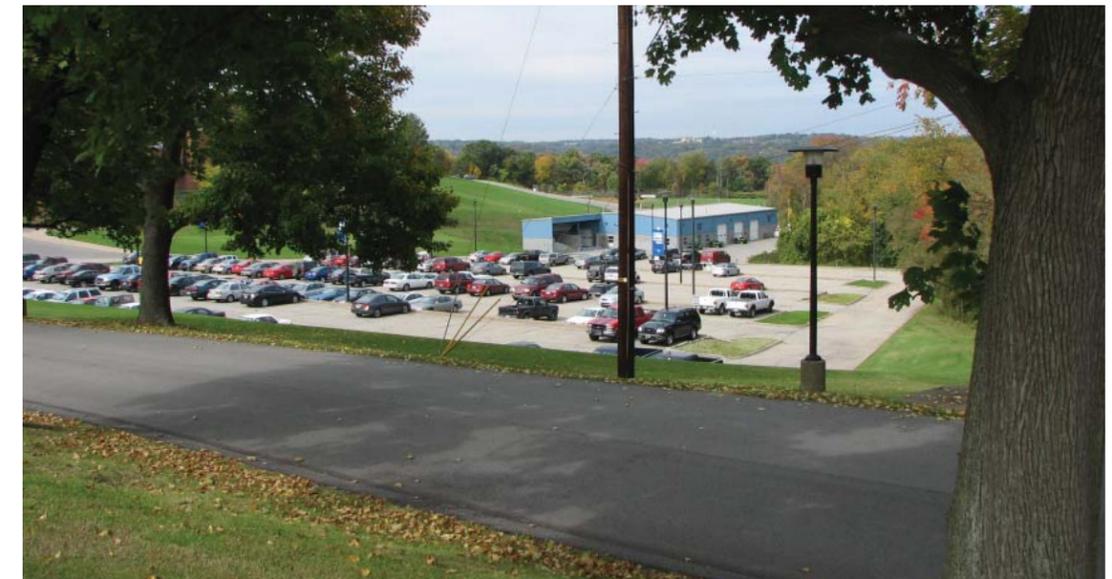
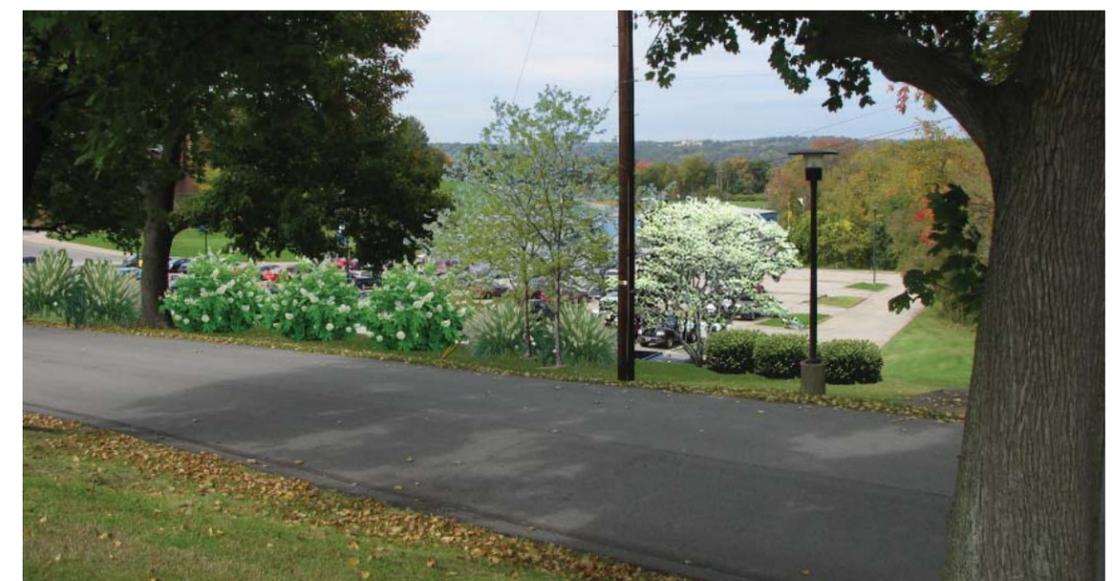
4F

Wherever possible, parked cars should be screened from view. The east lot next to the Physical Plant Services Building is a good example. Utility access will impact tree and shrub locations.

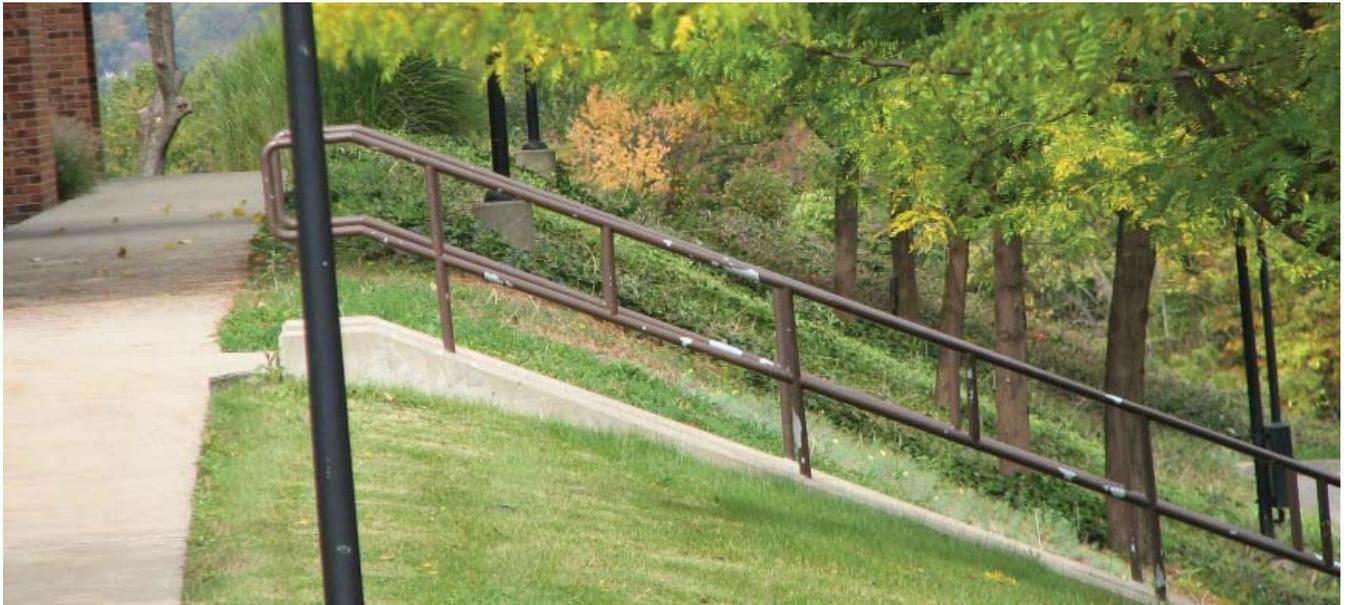
Chipping handrails should be painted.

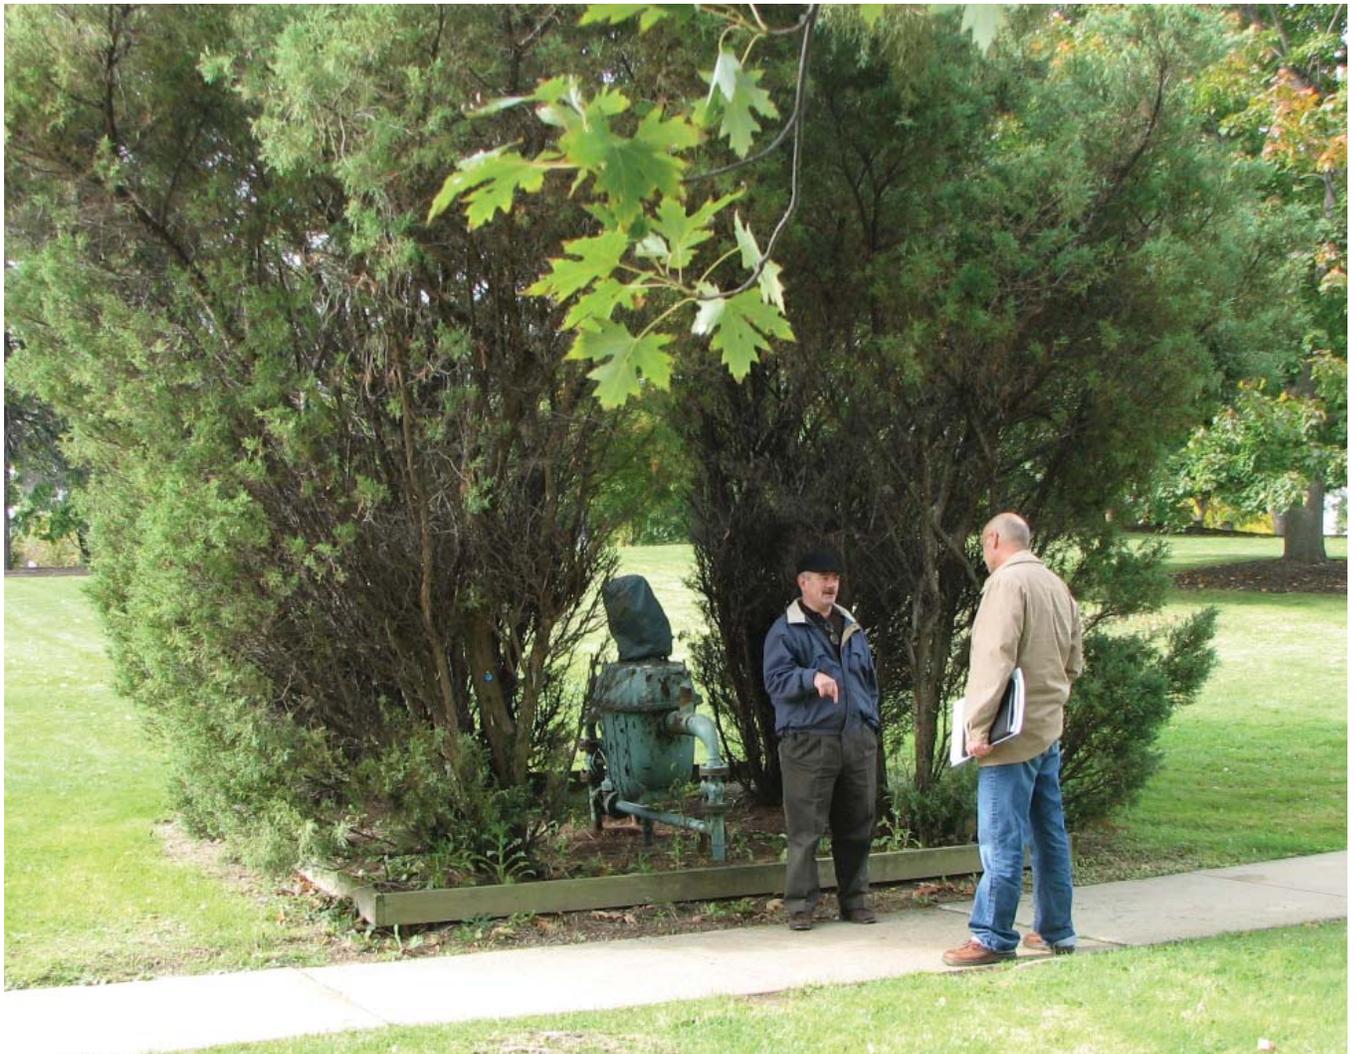
As mentioned in the LaQuantra Bonci study, the gas service equipment should be relocated from its current location on the main campus green. If relocation is not feasible, the equipment should be repainted and the landscape should be replaced to minimize the visual impact.

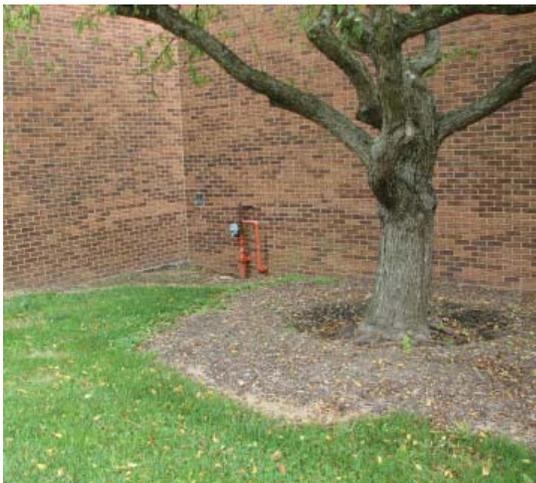
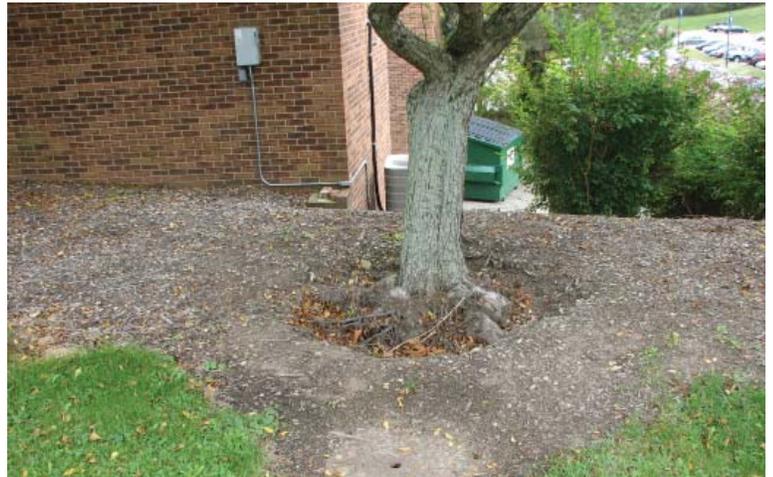
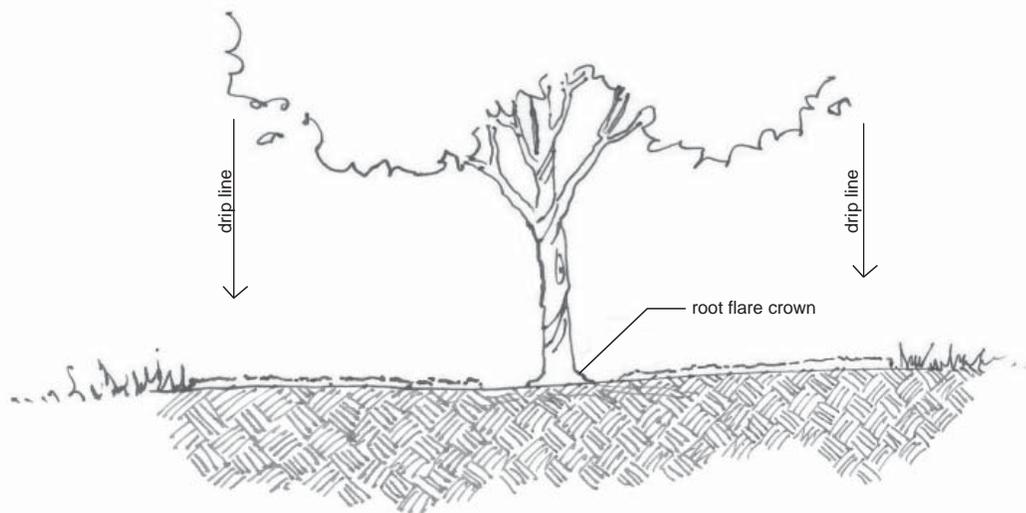
The bases of the trees fronting the Baker Engineering & Science Building have been air-spaded for root examination by Bartlett Tree Services. After backfilling with stone, as Bartlett suggests, cover with mulch to the dripline.

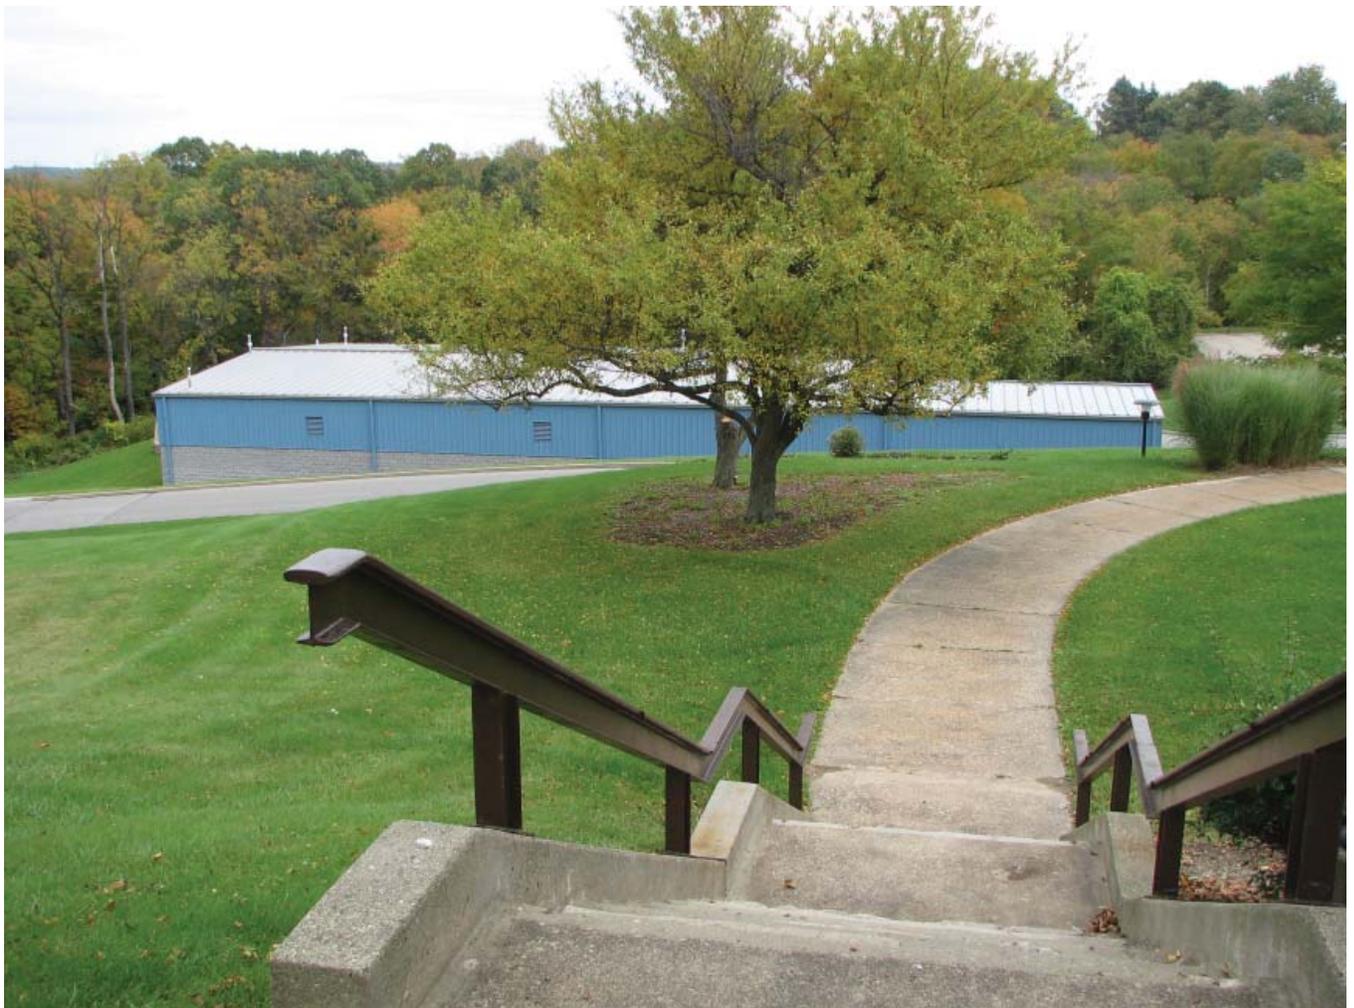
During the planning of the Overlook Pavilion next to the library, care should be taken to screen the view to the Physical Plant Services Building without obscuring the long desirable views to the mountains beyond. This stair and railings are in need of replacement and should be included in plans for the Overlook Pavilion.
