# Penn State Beaver

Campus Exterior Architectural Plan  
Spring 2010

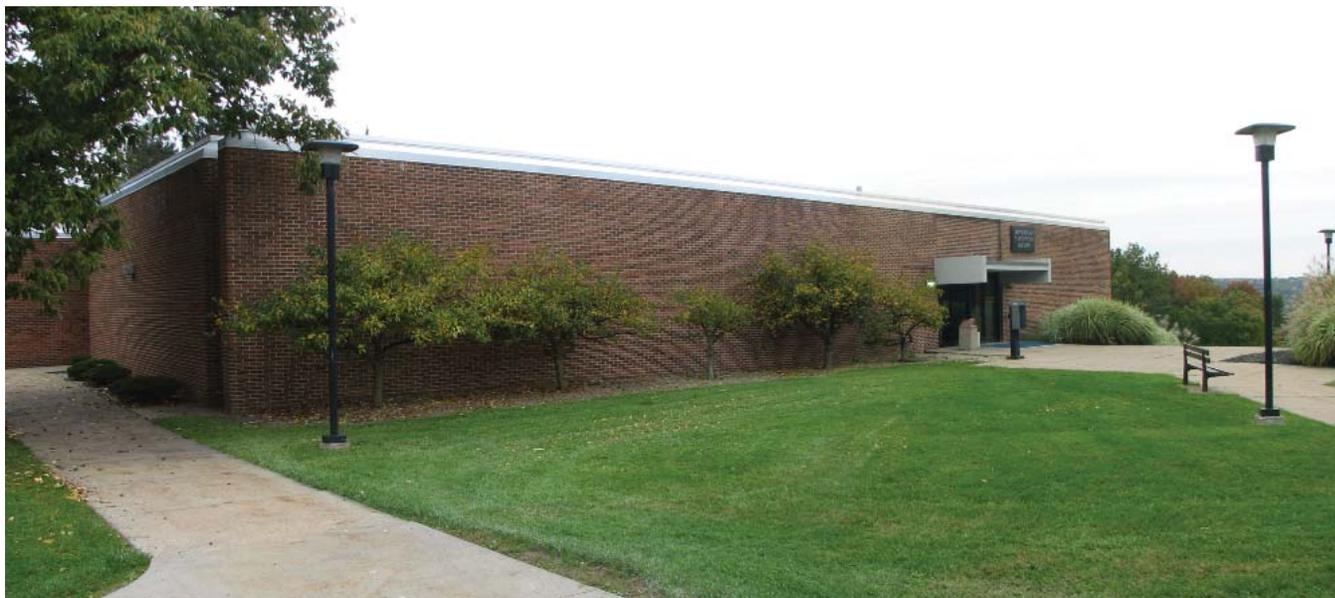
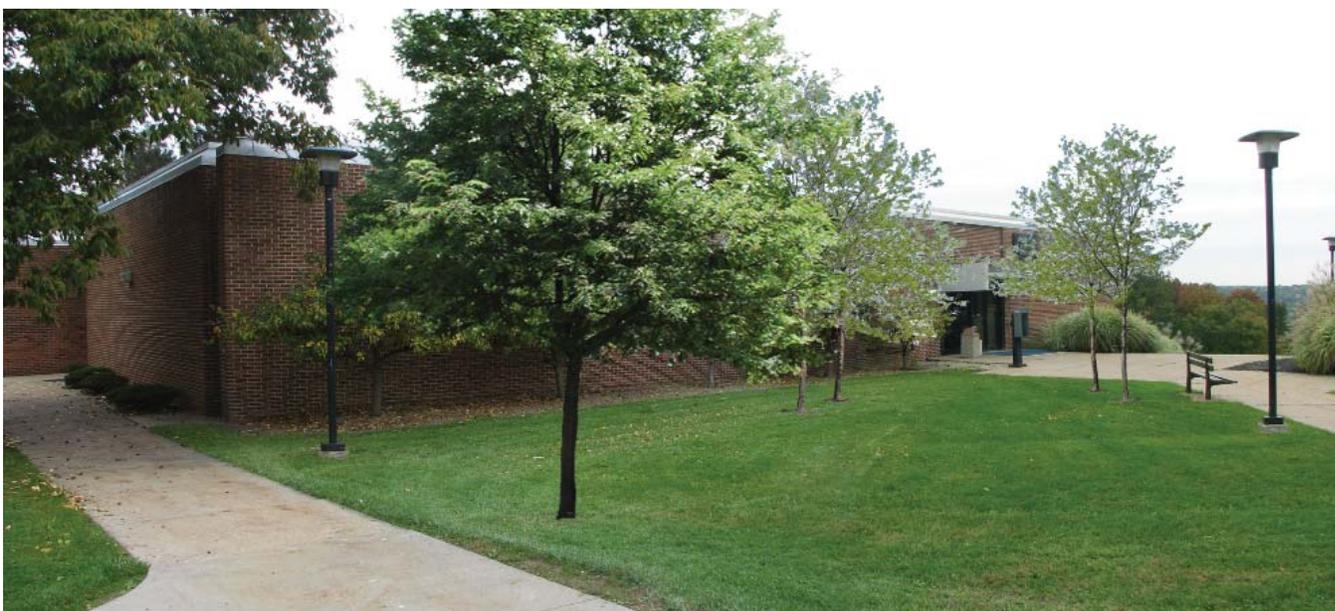
The landscaping at the Laboratory Classroom Building is not in scale. Large shade trees are recommended.

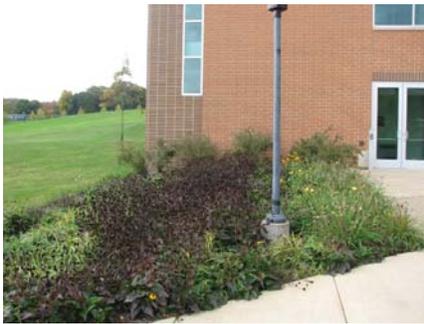
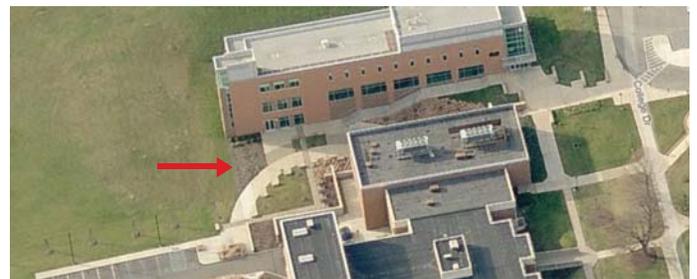
## Planting Bed at Ross Administration Building

A stronger planting design that is visually tied to the surrounding plantings is recommended for the bed on the southeast corner of Ross Administration Building. Right now the bed is dominated by perennials in need of thinning. The illustrated planting design would provide balance and scale and would unite this overgrown bed with the rest of the elegant plantings within the plaza.

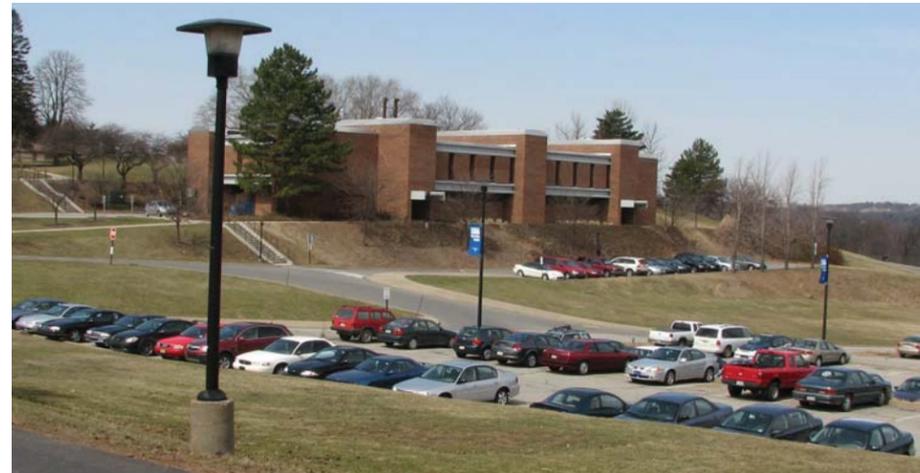
Install stairs at north end of parking lot behind Baker Engineering at site of existing “cowpath” desire line. Plant the remainder of the space between stairs to encourage use of stairs.

Existing desire line - site for new stairs

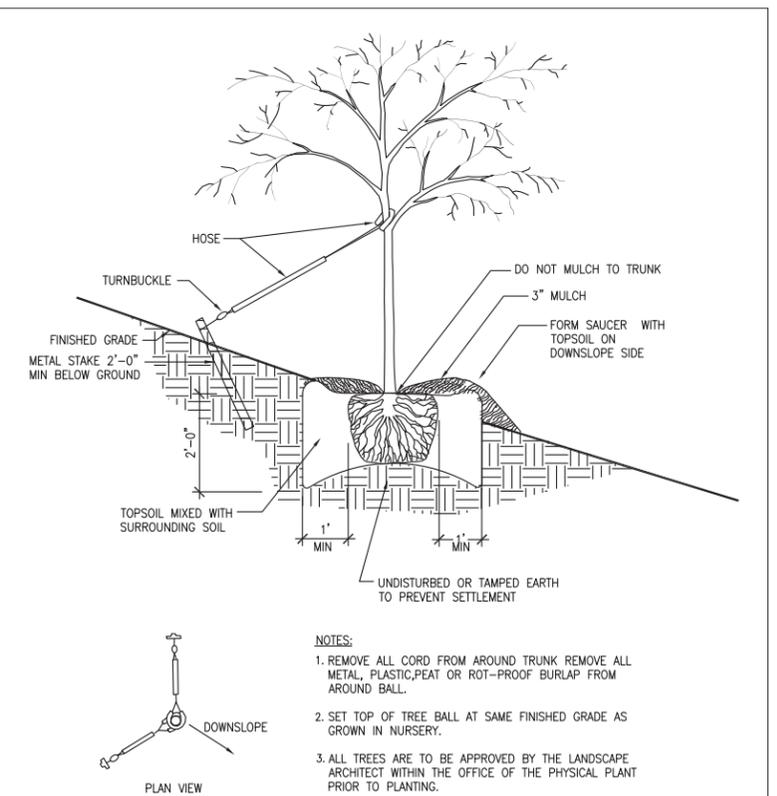
SLOPE TREE PLANTING AND GUYING  
SCALE: NONE

- NOTES:**
1. REMOVE ALL CORD FROM AROUND TRUNK REMOVE ALL METAL, PLASTIC, PEAT OR ROT-PROOF BURLAP FROM AROUND BALL.
  2. SET TOP OF TREE BALL AT SAME FINISHED GRADE AS GROWN IN NURSERY.
  3. ALL TREES ARE TO BE APPROVED BY THE LANDSCAPE ARCHITECT WITHIN THE OFFICE OF THE PHYSICAL PLANT PRIOR TO PLANTING.

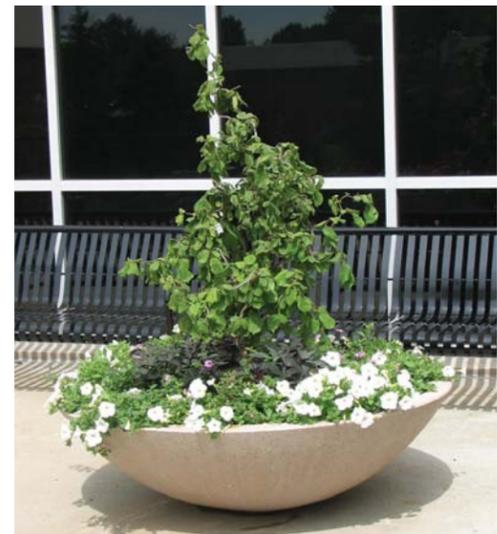
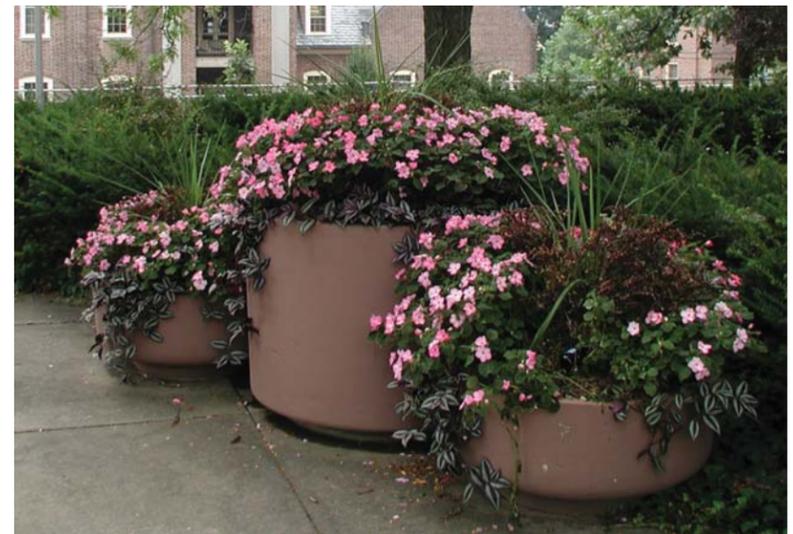
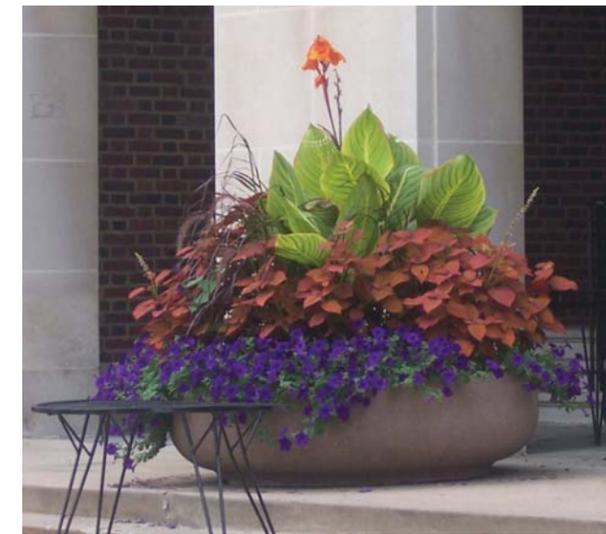
Examples of container plantings designed to incorporate all types of vegetation with dramatic visual effect

A dramatic visual effect can also be achieved by annual and perennial plantings in appropriately scaled containers placed strategically near building entrances and outdoor gathering spaces.

Recommend the placement of planters at various building entrances.

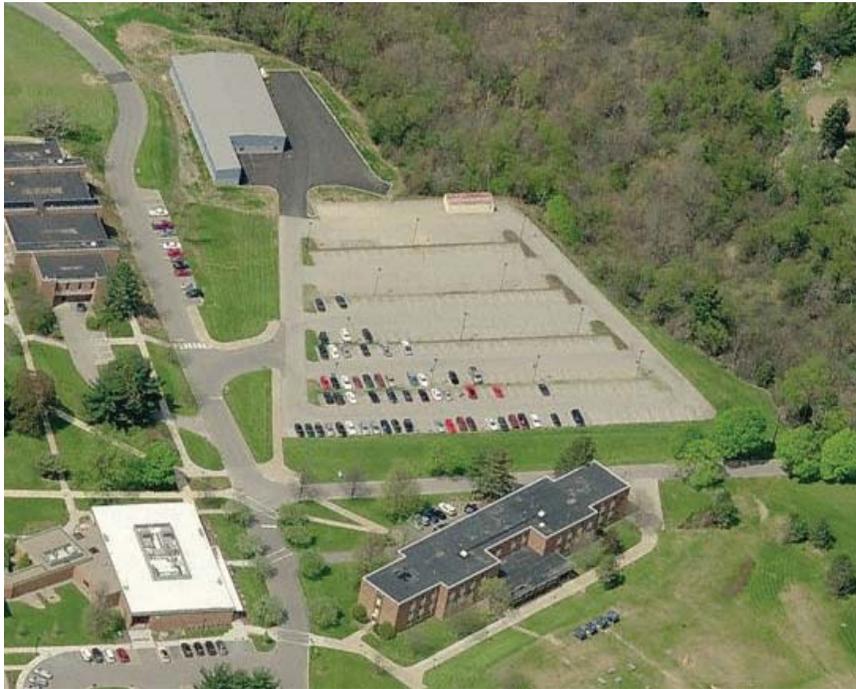
Campus representatives are considering a redesign of the parking lot east of the campus core. Plant island shade trees as part of existing or new configuration.

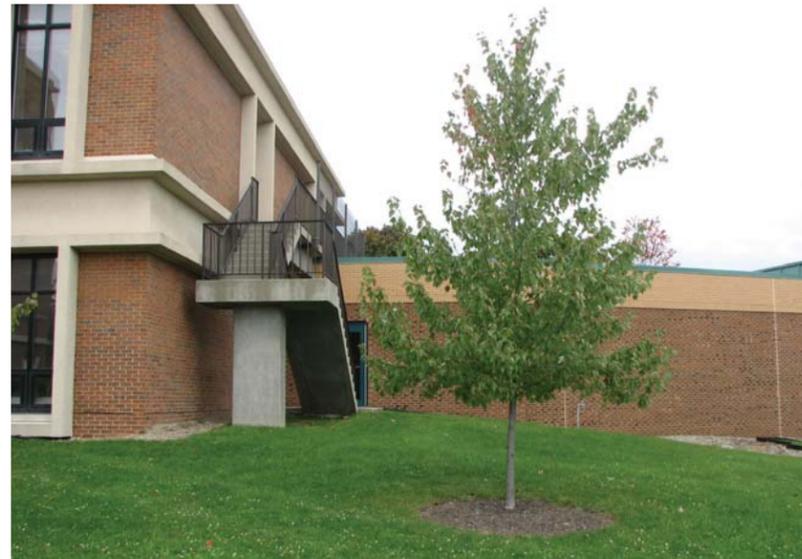
Campus representatives state that water does not flow from drainage pipes during storm events. Replace gravel with turf. Engineering plans of drainage system should be studied to determine if further plantings can be supported. If so, evergreen trees and shrubs such as American Holly and Inkberry Holly should be planted in corner and surrounding pipes. Screen the support for the stairs.

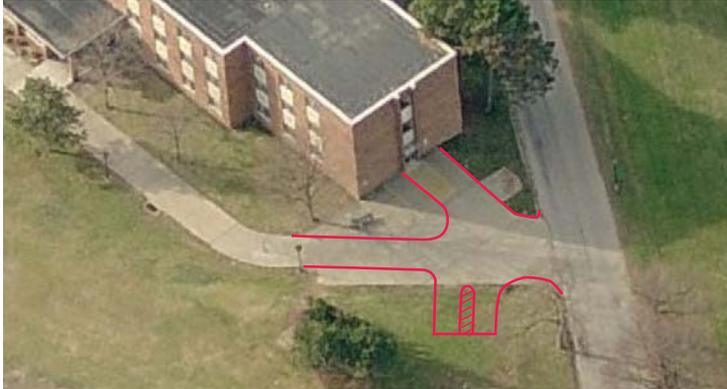
Overabundance of pavement contributes to excess water runoff and solar heat island effect. Green space is more visually pleasing than paved surfaces. The opportunity exists to reduce pavement and provide a more functional handicapped parking area outside Harmony Hall.

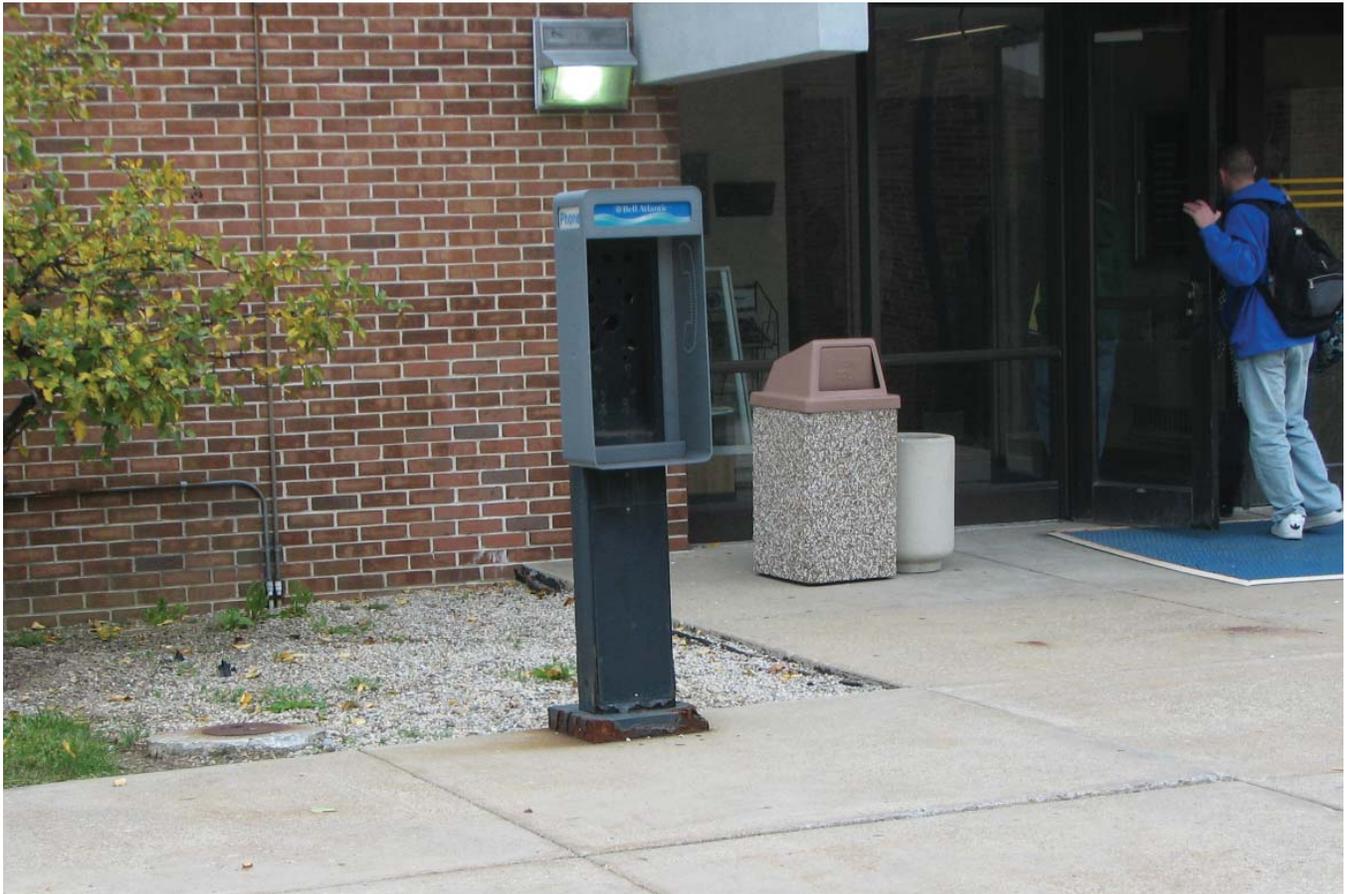
Remove the non-functioning phone booth as soon as possible.

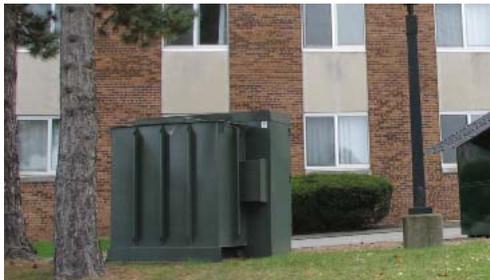
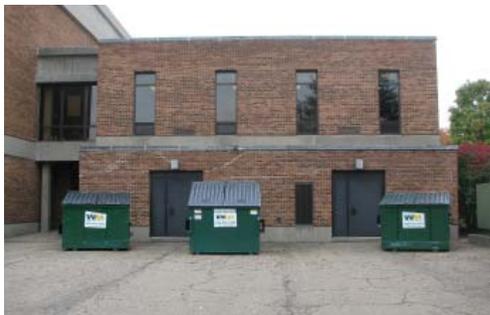
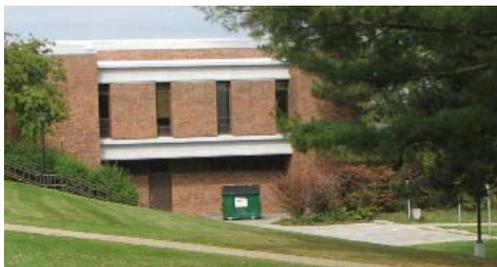
Unsightly transformers, AC units and other utility infrastructure are necessary for the operation of the campus.

Recommend that landscape planting and/or view obstructing fence material be installed to diminish the negative visual impact of utilities.
