Campus Exterior Architectural Plan 2.0

Scranton

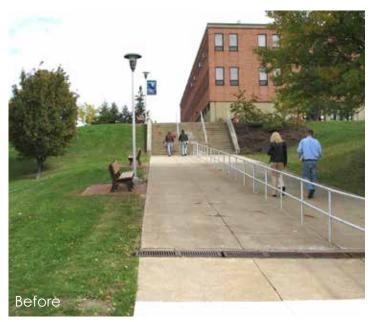
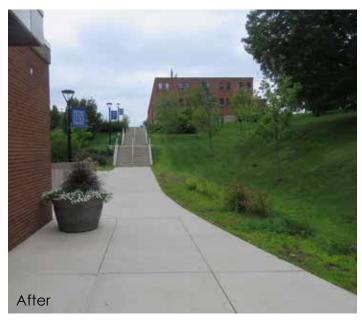
Wide ramp & steps replaced and narrowed

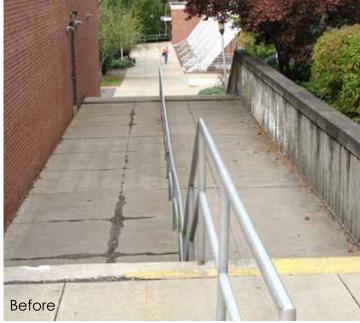
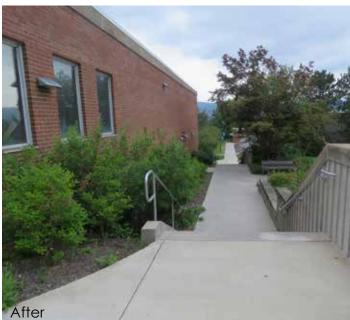
After Steps and walkway width reduced by half

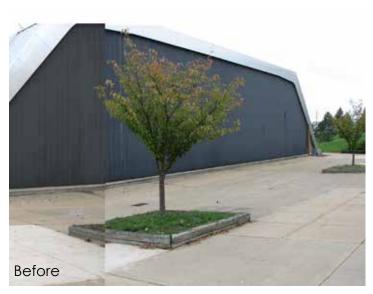
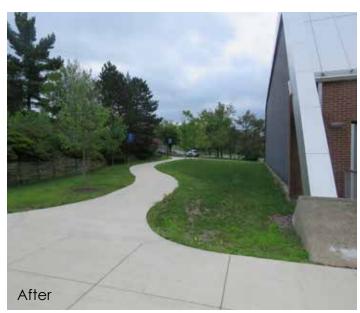
Large concrete plaza removed at Gymnasium

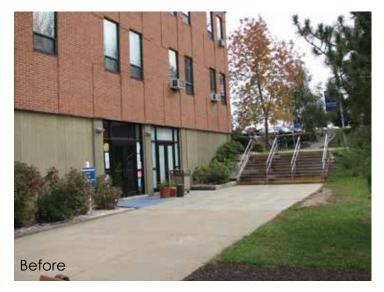
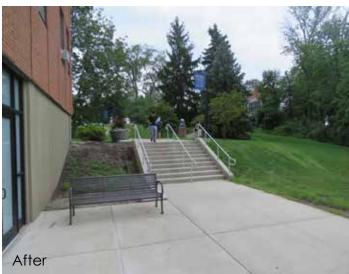
Walkways and steps replaced and narrowed through core campus

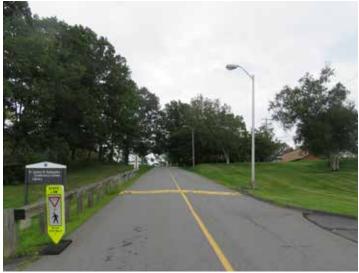
Cobra-style lights on Campus Hill Road

Plan for phased replacement of antiquated, inefficient walkway, roadway and parking lot lighting

The use of metal halide lamps in cut-off luminaries mounted to poles is recommended. Avoid the use of bollards due to vulnerability to snow removal operations and vandalism.

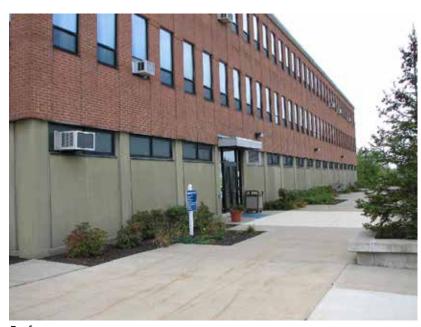
Before

Window air conditioning units have been improved in efficiency and aesthetic appearance. Utilize units that are less visible on the exterior.

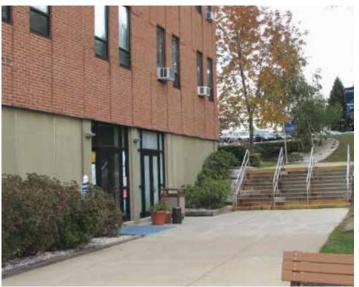
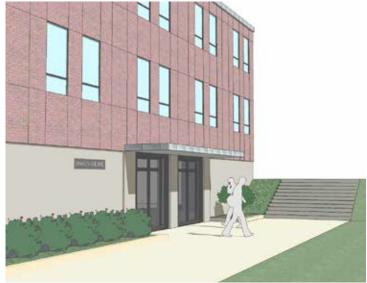
Existing

The existing entry points to Dawson Building are nondescript. A roof or awning structure at each entry point will visually identify the entrance as well as provide shelter from inclement weather.

The design and material for the awning must complement the architectural style of the building. Other instances occur across campus that would benefit from this treatment. Examples include the Nursing Education entrance at the Library and Police Services.

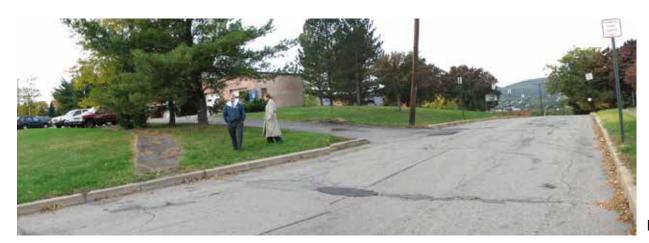
Existing

Pedestrian access to campus from public transportation at O'Neill Highway requires walking in the street or grass for at least a portion of the route. Propose the installation of a sidewalk from campus to the highway.

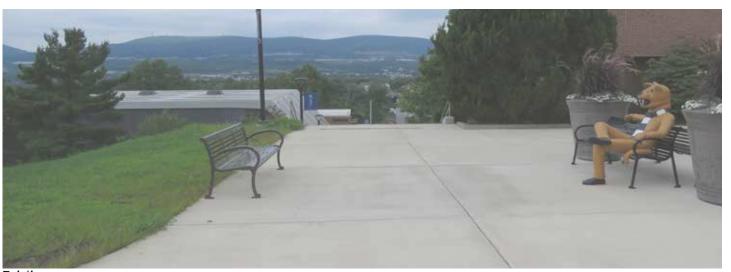
Existing

Walkway not accessible; Statue base inconsistent w/ original Main. bldg. is backdrop; Furnishings incongruous w/ campus

Because of inaccessibility, inappropriate base, inconsistent paving materials and furnishings, and a poor background for photography, consider relocation of the statue to the west end of the Dawson North Courtyard as a focal element with the mountain view as a backdrop. This could be integrated into a project to redesign the entire north Dawson courtyard (Updated Recommendations #3, page 30 - 32)

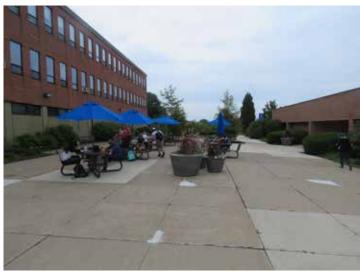
Site furnishings have been upgraded which is a great start

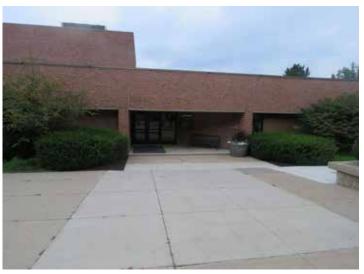
Excessive, patched pavement and tired landscaping

The plaza between the Student Study and Learning Center and the Dawson Building currently has outdated landscaping and an excessive amount of deteriorating concrete. Recommend a plaza redesign to address these issues and create a more inviting space. The lion shrine relocation (Updated Recommendations #2, pages 28 - 29) can be incorporated into this project to become the focal point of the plaza.

- Replace tired landscaping
- Create better seating opportunities
- Eliminate unnecessary concrete
- Introduce more vegetation and trees
- Relocate and better integrate the lion shrine
- Create an attractive and cohesive space for students

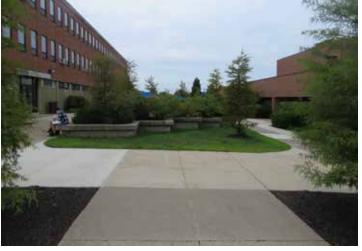
Tree pits unnecessary and stunt tree growth

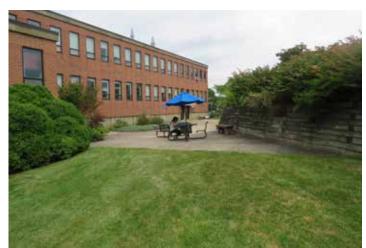
Unattractive walls and unnecessary pavement

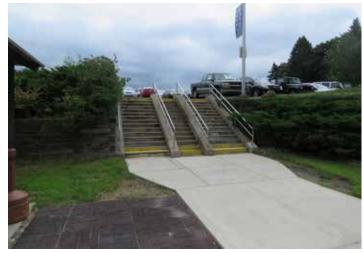
Steep steps with no landings & mismatched retaining walls

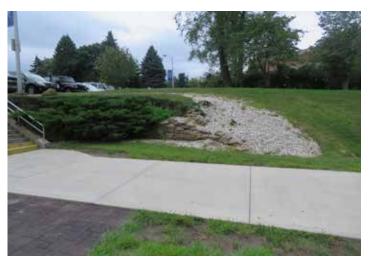
Tired landscaping but with potential for ADA ramp

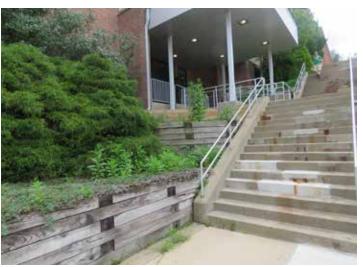
These steps are very steep and are unsightly from numerous repairs, as well as pose a serious maintenance and safety issue in winter. Timber retaining walls are residential in character and plantings are unruly and weedy. Replacement of steps seems imminent, which may provide an opportunity to consider options for a new alignment that is safer and easier to maintain. Consider these safer and lower maintenance design options looking forward.

Looking south at formidable climb with undesirable plantings Close up of mid-level entrance from below

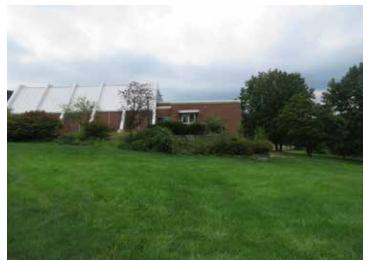
Plantings within walls are unruly and unkempt

While a recent pavement reduction project has improved the south side of the Gymnasium, other landscape issues are present along the other three facades. Timber retaining walls throughout the campus are dated and residential in appearance and not long-term solutions. Consider other wall systems or regrading areas to create landscaped embankments. Ongoing pavement upgrades and "hiding the uglies" approaches are needed.

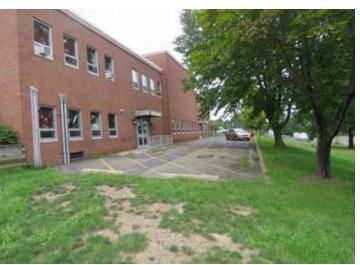
Parking, access drive, & building entrance are in disrepair

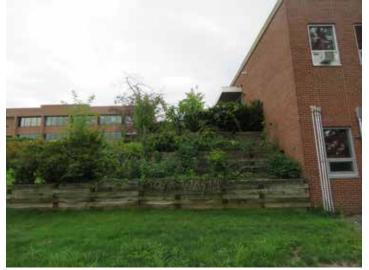
Timber walls are unattractive and not long-term solution

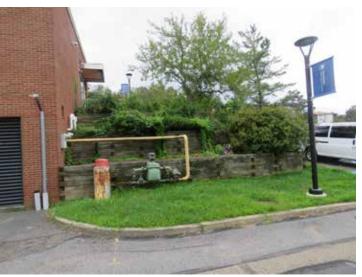
Utility pipes and meters are unsightly

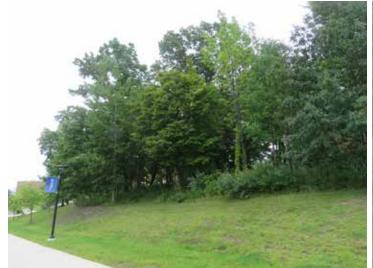
Invasive shrubs choke out desirable species & block views

This woodlot in core campus is both an educational opportunity and campus amenity similar to Hort Woods at the University Park Campus. However, rehabilitation efforts are needed, including the removal of invasive plants and dropping hazardous trees (dead ash), as well as planting desirable native plants in canopy gaps and along edges and protecting the woodlot from further encroachment of development. Consider the potential expansion of forestland into turf areas that are not programmed spaces.

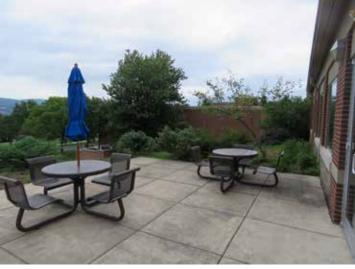
The pavement, site furnishings, and plantings were recently updated surrounding this building. However, a combination of design, construction, environmental, and/or maintenance factors have resulted in missing plants, poorly placed plantings, and unrealistic expectations for landscape maintenance.

Maintenance and/or plant selection & health issues detract
